# Assessment of 47 Lakes in the Manawatu-Whanganui Region using LakeSPI

NIWA CLIENT REPORT No: 2021157HN  
Report date: June 2021  
NIWA Project: HRZ19201

Horizons Regional Council contracted NIWA to report on the ecological condition of 47 lakes in the Manawatū-Whanganui region using LakeSPI (Submerged Plant Indicators). LakeSPI is a bioassessment method that uses the degree of development by native submerged plants, and level of impact by non-native, invasive weeds to indicate a lakes ecological condition. Lakes were assessed over five main survey occasions between November 2015 and December 2020. New or repeat surveys carried out for inclusion into this report included: Alice, Dudding, Centennial (Hokowhitu) Lagoon, Namunamu, Pauri, Pukepuke Lagoon, Virginia (Rotokawau), Waipu and Wiritoa.

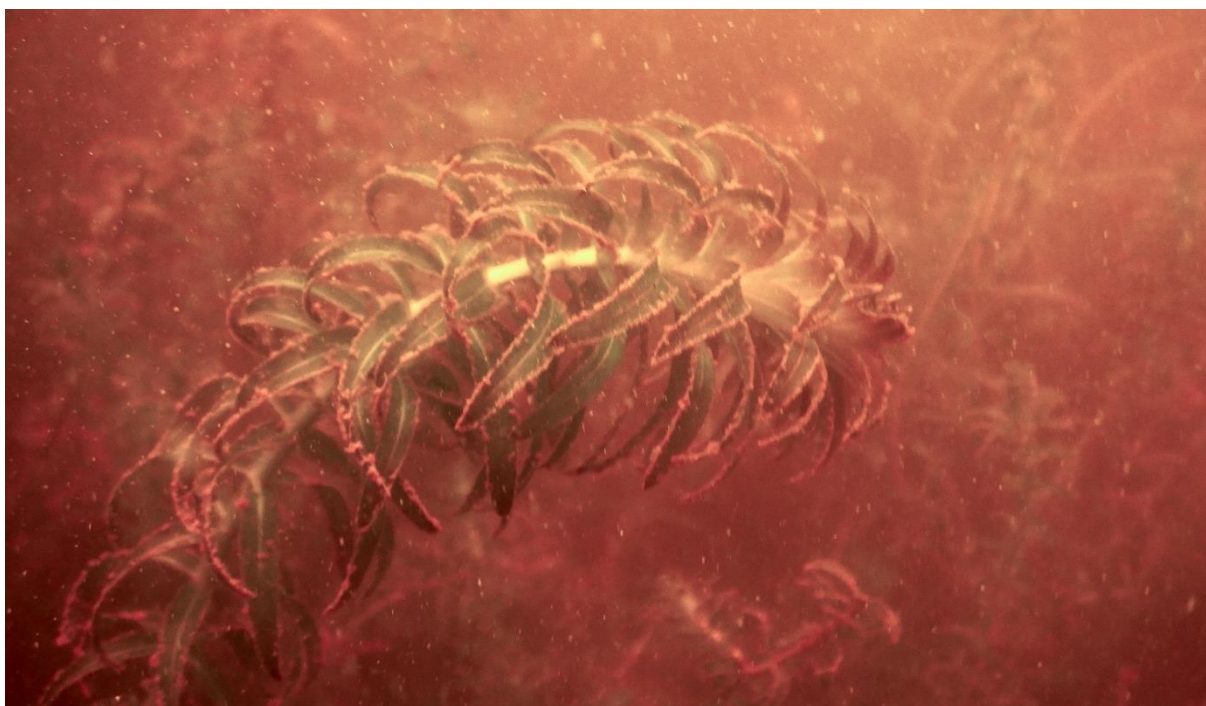
Invasive weed species egeria (*Egeria densa*) (Figure 8) and elodea (*Elodea canadensis*) formed clumps of near surface reaching weed (tops removed by swans) at all LakeSPI sites, extending across the lake bottom. An introduced pondweed *Potamogeton crispus*, was also recorded.

**Figure 8:** Egeria in Lake Alice (Photo, 2020).

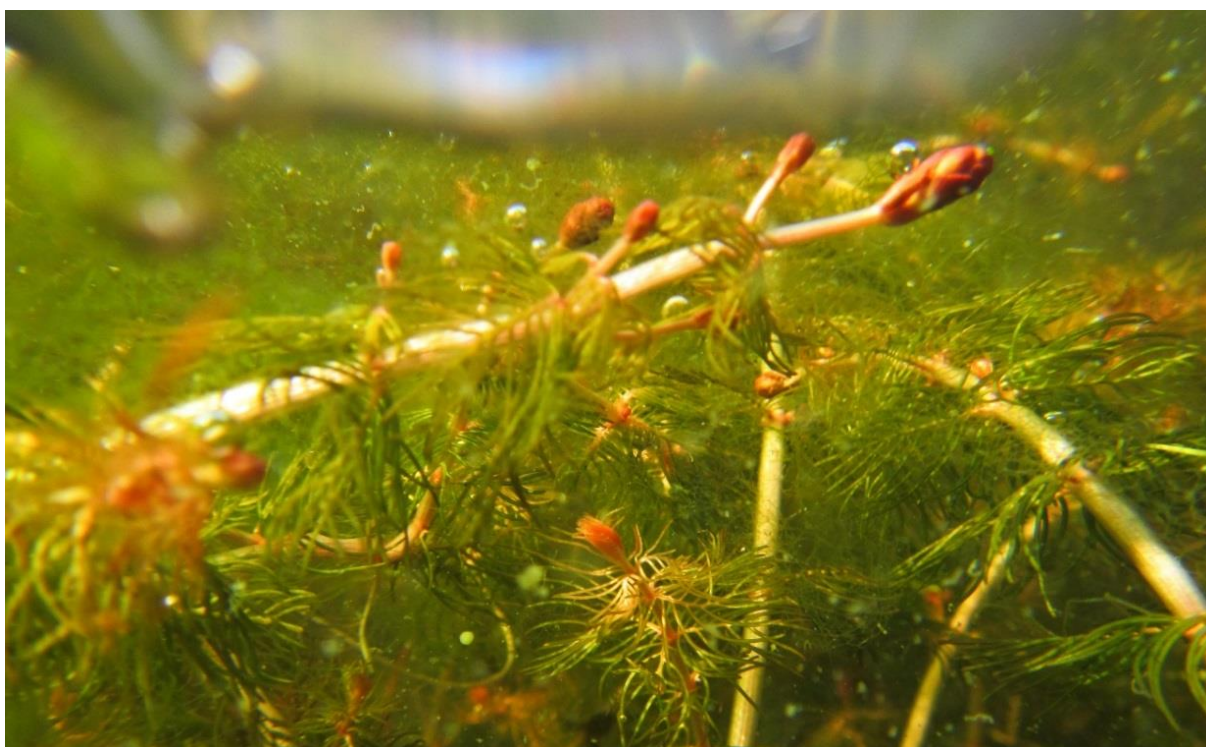
Two native submerged plant species were recorded in Lake Alice. A native milfoil species *Myriophyllum triphyllum* was the most abundant of these with its flowering stems forming surface reaching (Figure 7 and Figure 9) bands along the lake margins growing down to a maximum depth of 2.3 m. A native pondweed *Potamogeton ochreatus* was also present. Moderate to high covers of these native species contributed to a Native Condition Index of 38% (Figure 6).

**Figure 9:** The red flowers of *Myriophyllum triphyllum* were visible on the surface of Lake Alice (Photo, 2015).

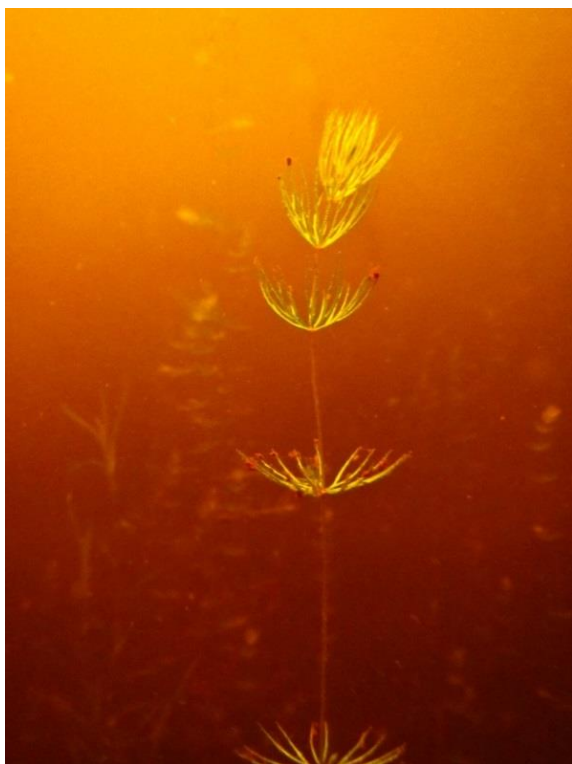
Hornwort (*Ceratophyllum demersum*) was present at all surveyed sites growing down to c. 3.2 m depth, with occasional shoots still found anchored in sediment below 5.5 m. Beds were variable in cover, forming a closed cover at only two of the four sites forming beds up to 2.2 m tall. Hornwort plants were etiolated, presumably as a result of low light levels, with whorls of leaves widely spaced along stems (Figure 12). *Potamogeton crispus* was also present at low covers.

**Figure 12:** Hornwort growing in Lake Bernard showing etiolated stems.

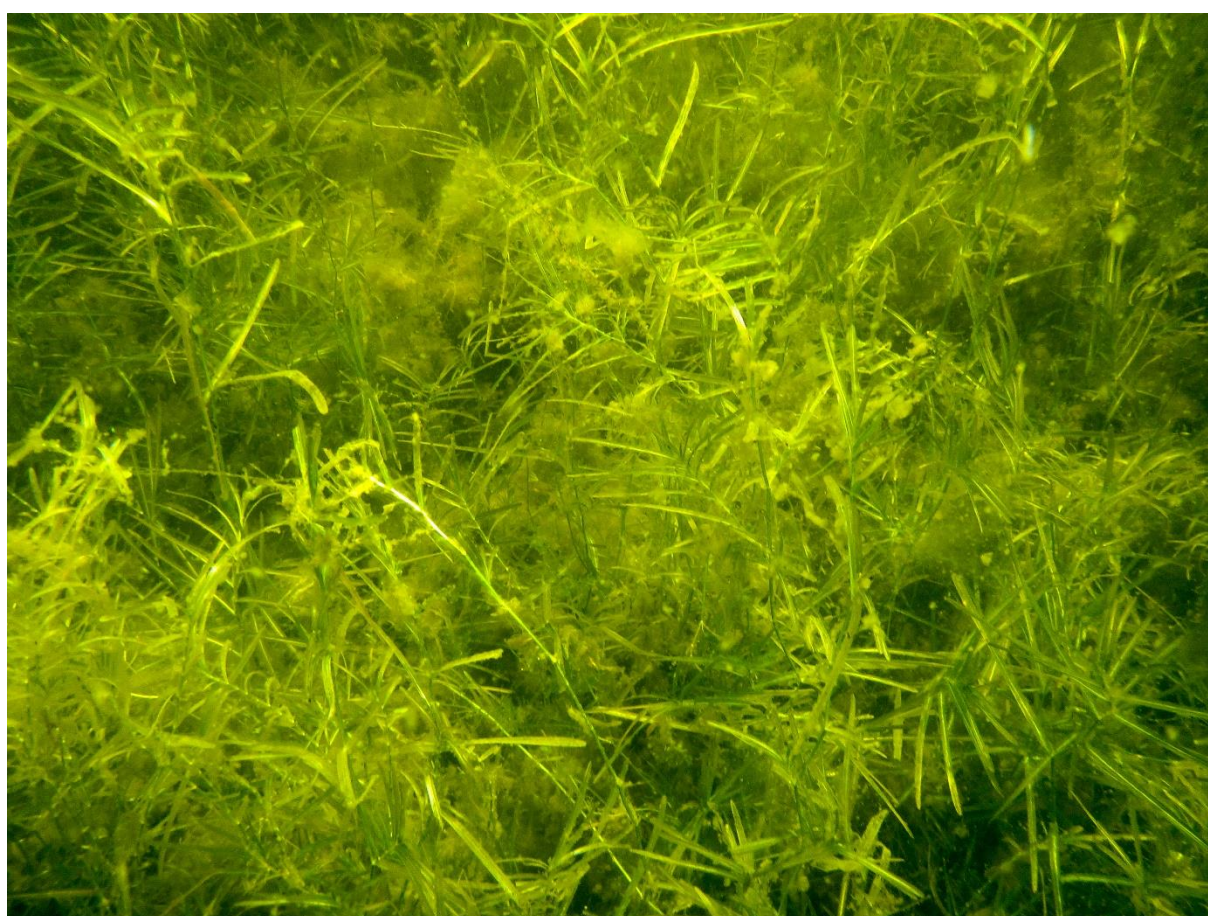
**Figure 16:** Native pondweeds (*Potamogeton ochreatus*) growing amongst charophytes in Christies Lake.

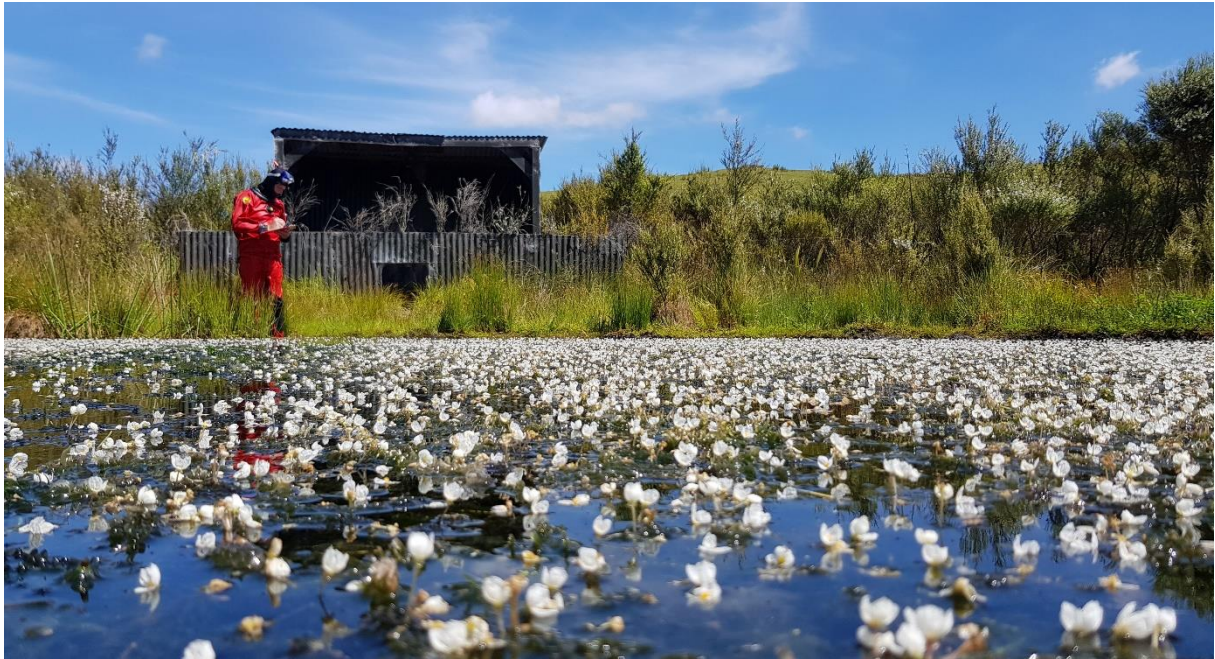
**Figure 17:** Egeria was surface reaching and flowering around the margins of Christies Lake.

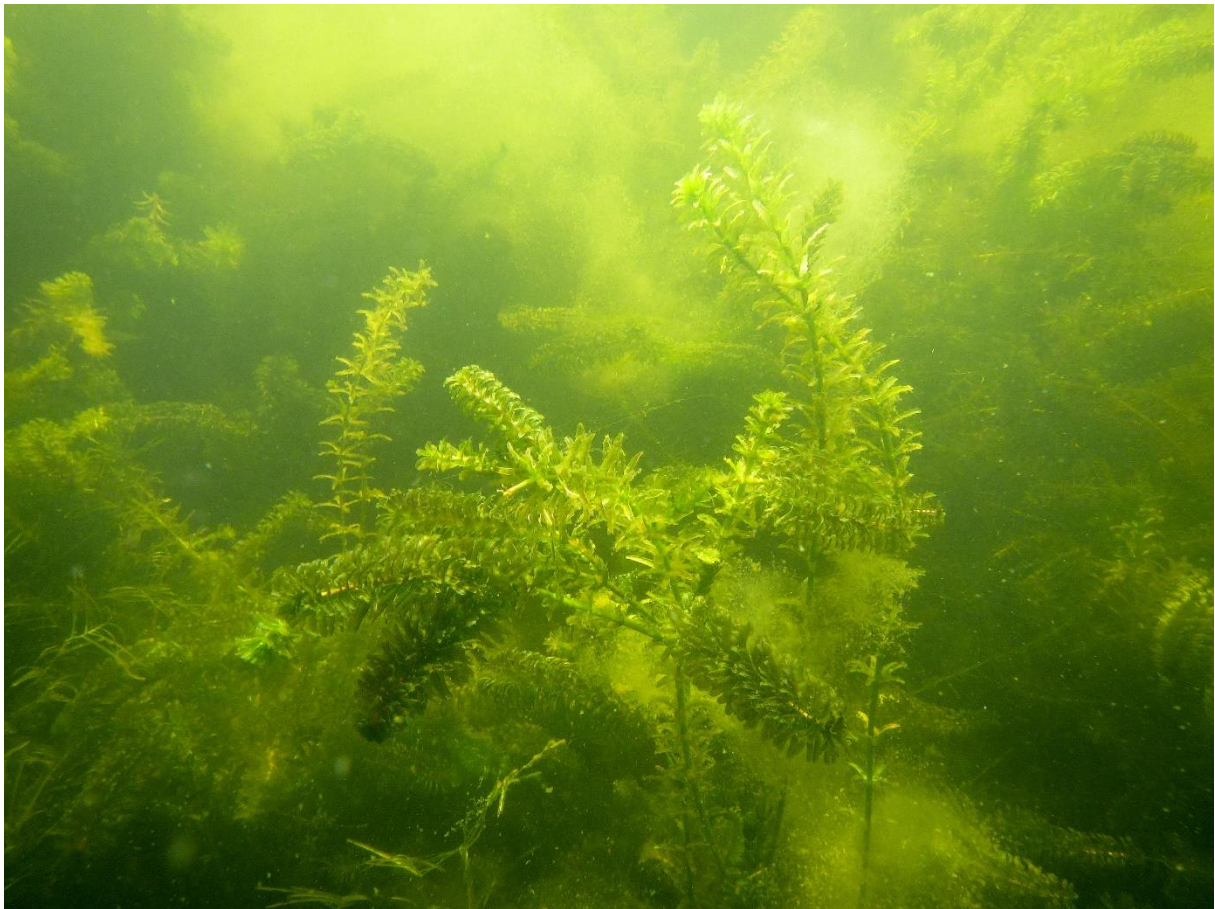
**Figure 18:** Egeria formed high cover patches across the bottom of Christies Lake.

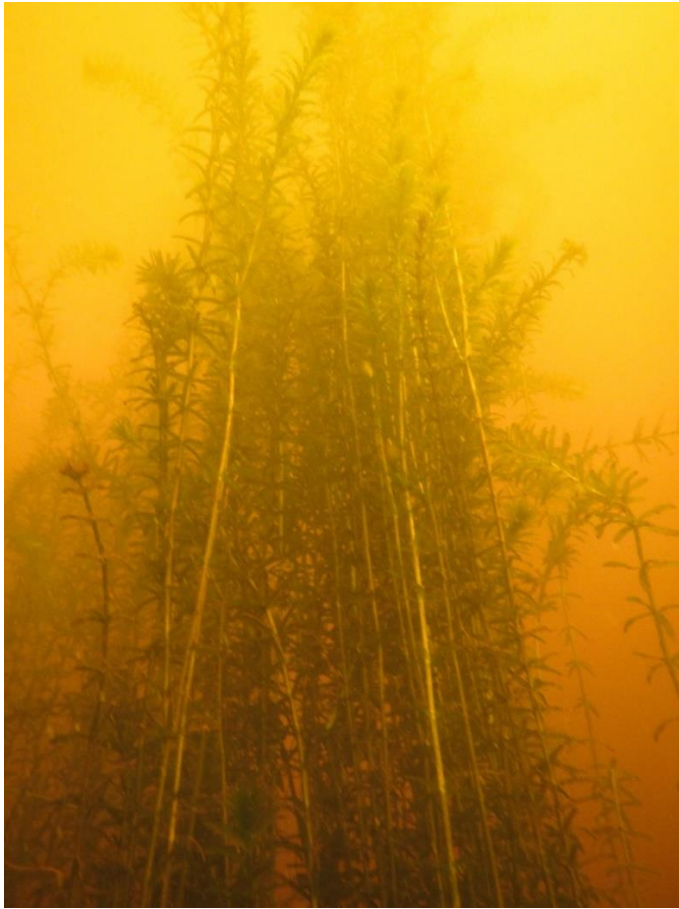
**Figure 20:** *Egeria densa* growing up towards the surface in Dudding Lake in 2015.

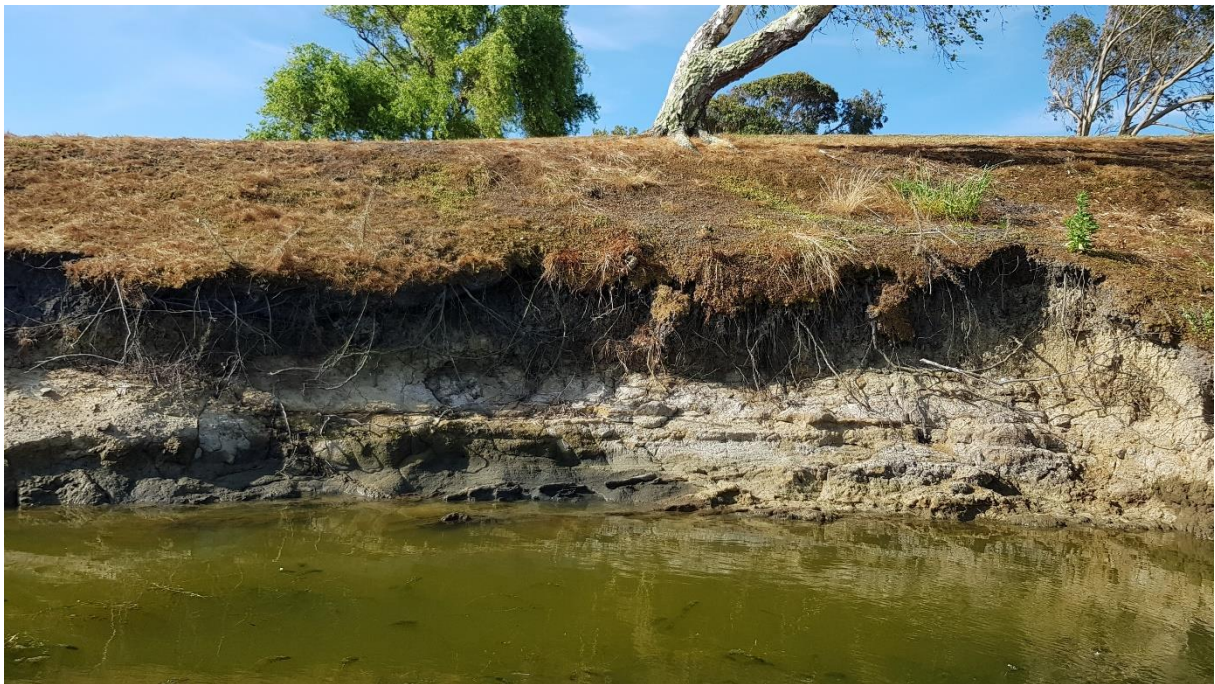
**Figure 21:** Exposed banks around Lake Dudding in December 2017.

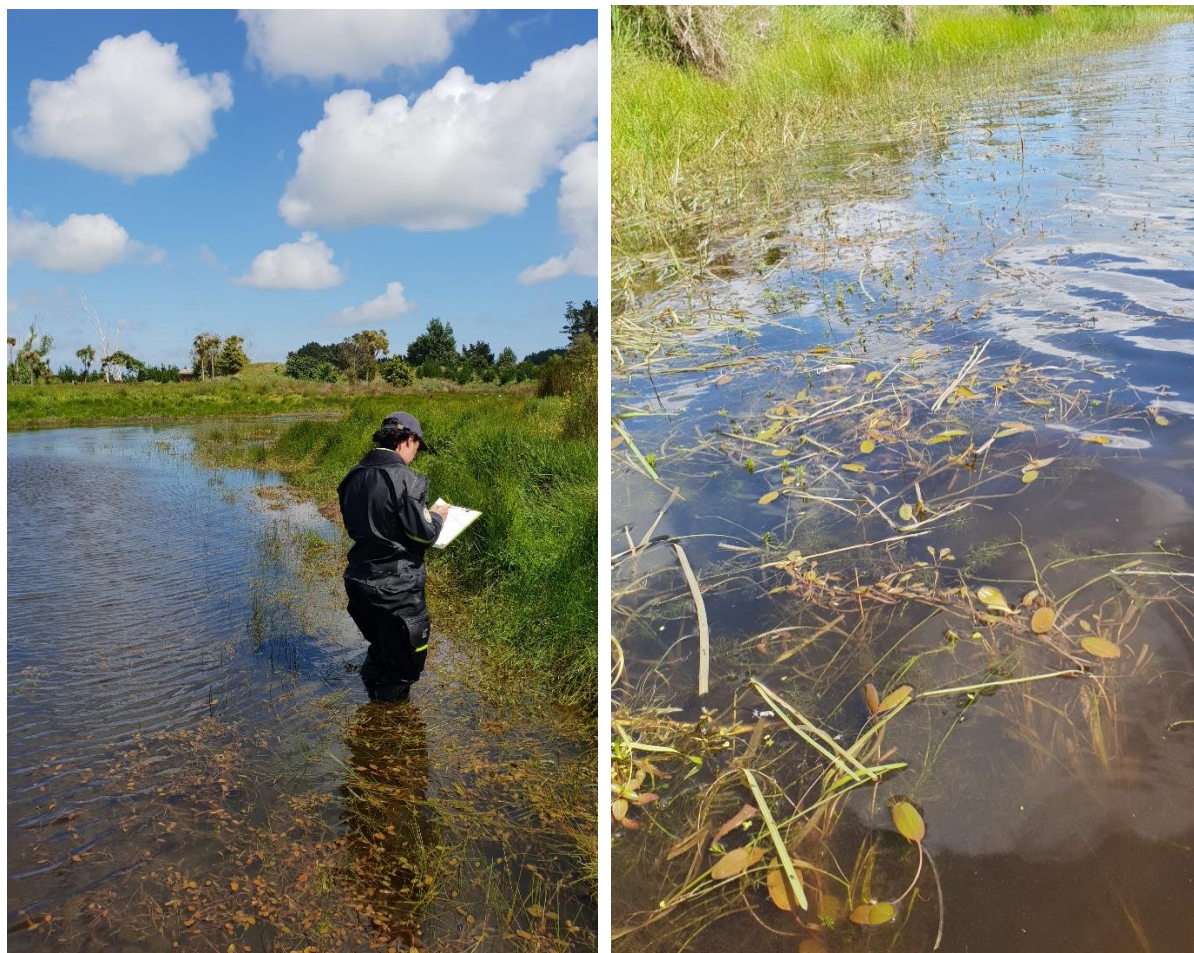
A narrow band of submerged plants, in most areas < 5 m wide, grew around the margin of the lake (Figure 23). Plants were surface reaching close to the lake margin and extended across the shallow lake bottom to a maximum depth of 0.9 m. The native pondweed *Potamogeton cheesemanii*, and milfoil *Myriophyllum propinquum* (Figure 24) were the most prevalent species present forming moderate to high covers up to 0.7 m tall at all five LakeSPI sites. Another native pondweed *Potamogeton ochreatus*, and an introduced submerged marginal species *Ludwigia palustris*, were also present.

**Figure 23:** Submerged plants formed high covers around the margins of Green Pond Wetland. Oval floating leaves of *Potamogeton cheesemanii* visible on right.

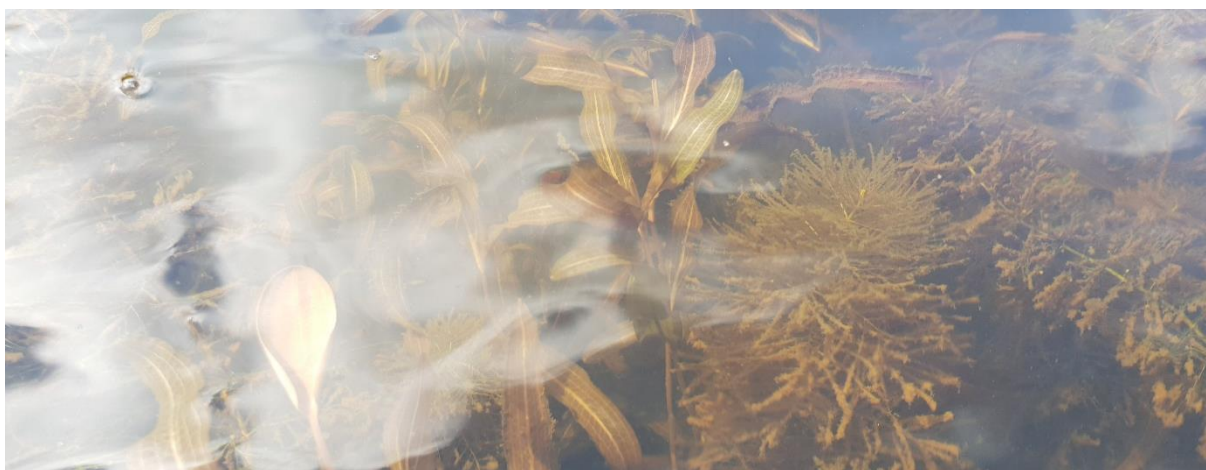
**Figure 24:** Native submerged plants *Potamogeton cheesemanii* and *Myriophyllum propinquum* growing just below the surface in Green Pond Wetland.

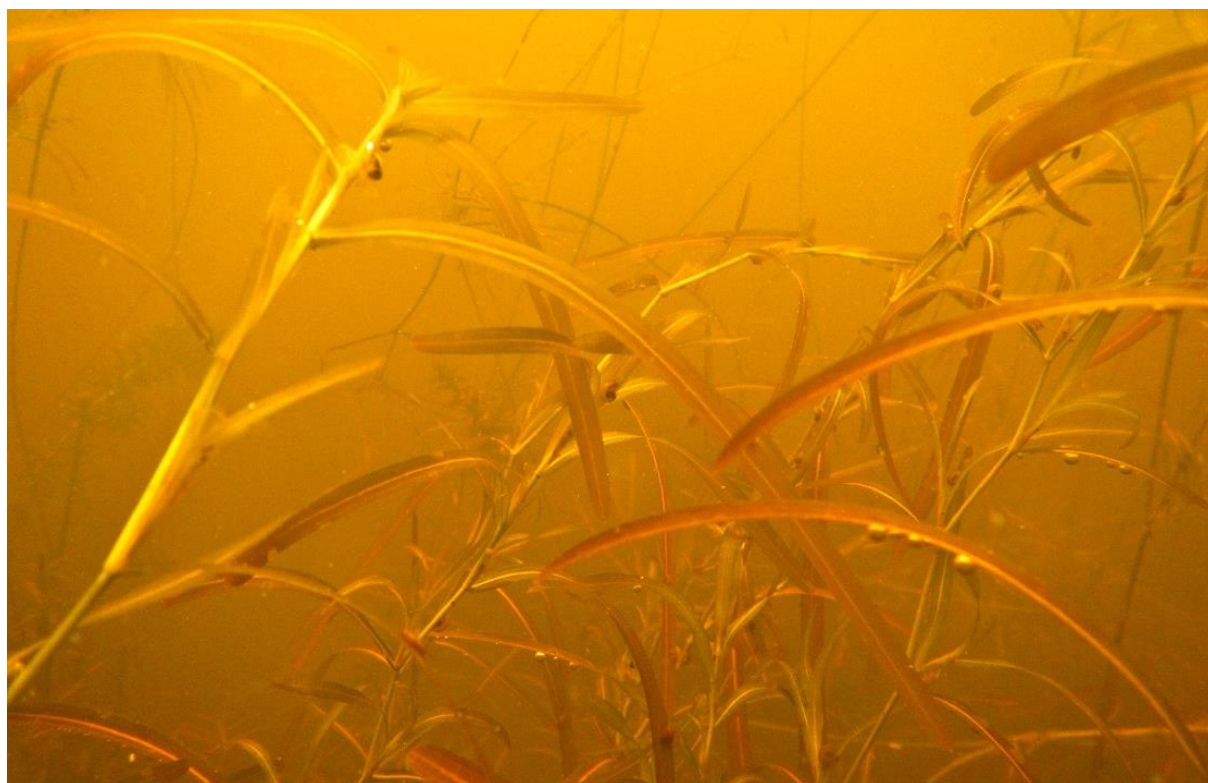
**Figure 26:** Native pondweed *Potamogeton ochreatus* formed high covers in Lake Heaton (2015).

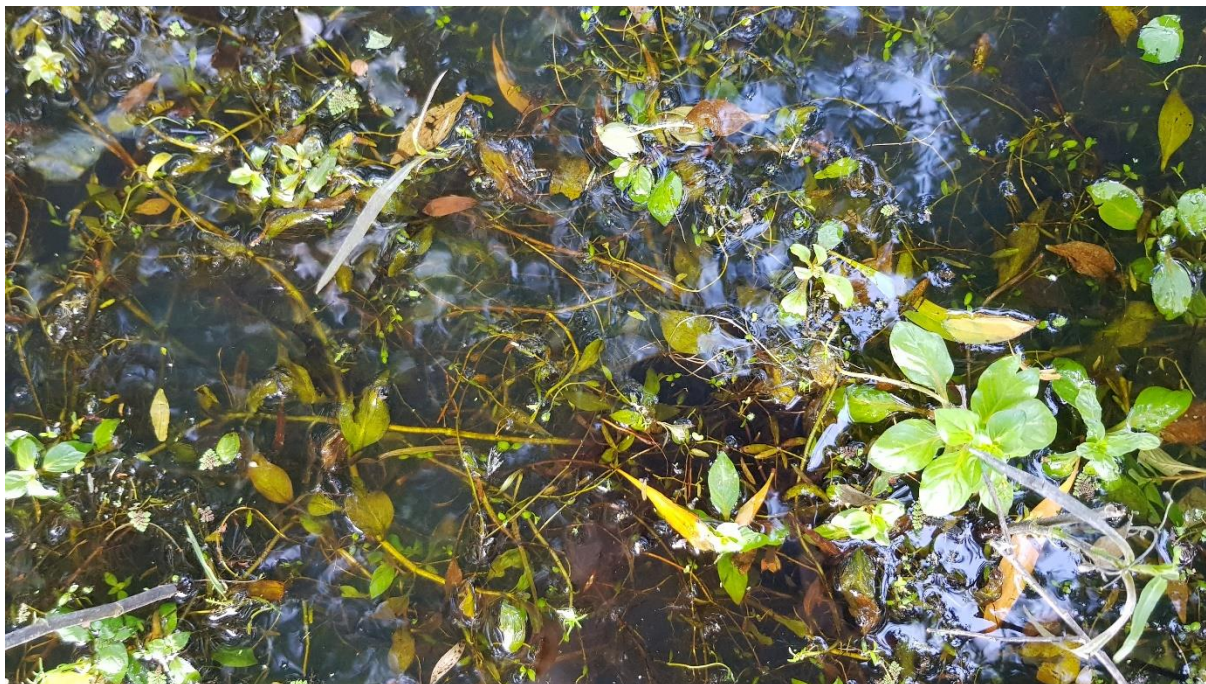
Native milfoil *Myriophyllum propinquum* was surface reaching at depths < c. 1 m at all four sites around the main basin of this lake. Sprawling emergents, *Ludwigia palustris* and *Persicaria decipiens*, and free-floating species *Azolla pinnata* and *Ricciocarpus natans*, were also recorded growing in this surface reaching mat near the margin (Figure 28).

**Figure 28:** Dense mat of submerged and sprawling emergent species in the shallows of Lake Herbert. *Ludwigia palustris* with big leaves and growing above the water surface.

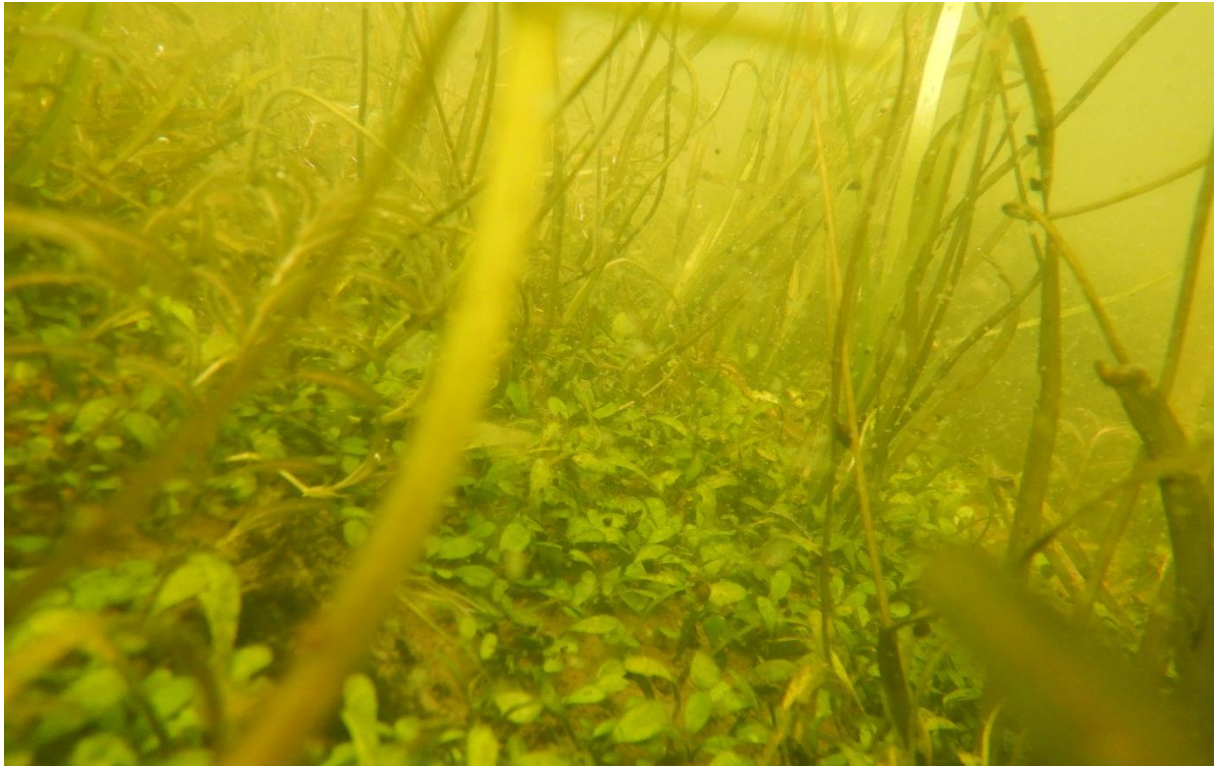
The discovery of swamp lily *Ottelia ovalifolia* in the Huia Road Dam, is the first time this species has been recorded from a LakeSPI survey in this region. Swamp lily is common in some local areas (particularly in Northland) where it is known to prefer fertile ponds and small farm lakes such as this dam.

**Figure 30:** Turf plant *Glossostigma elatinoides* formed high covers around the edge of the Huia Road Dam. Seen here growing below invasive plants *Potamogeton crispus* (left) and *Ottelia ovalifolia* (background) .

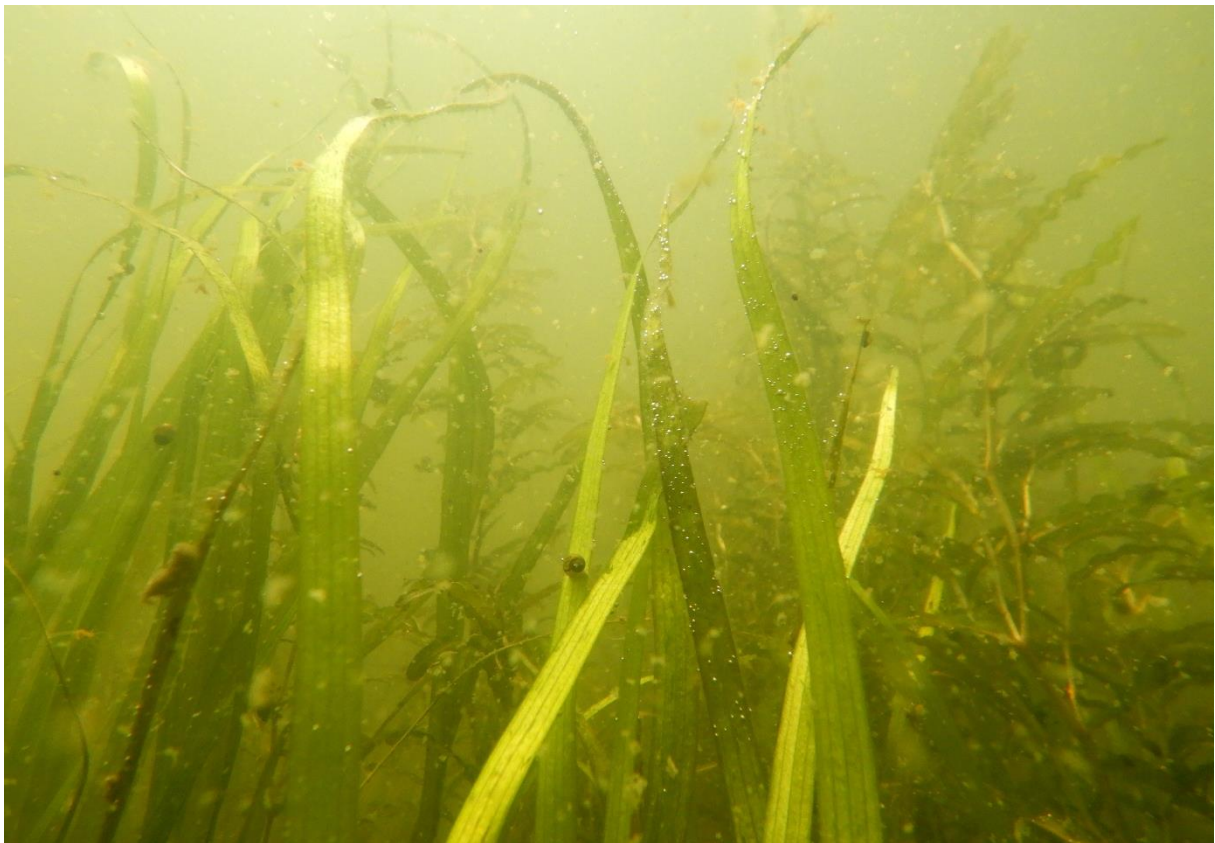
**Figure 31:** Strap like leaves of *Ottelia ovalifolia* growing to the surface in the Huia Road Dam. Introduced pondweed *Potamogeton crispus* visible on far right.

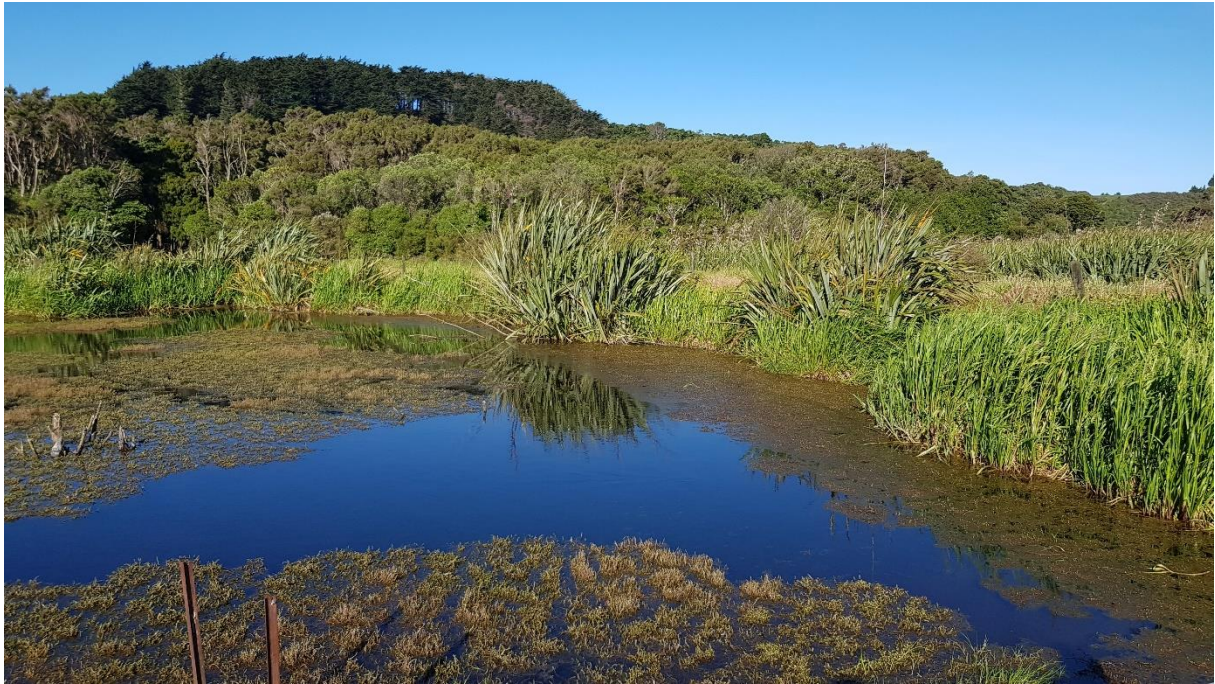
**Figure 33:** Surface reaching mats of *Myriophyllum propinquum* in Hukanui Swamp.

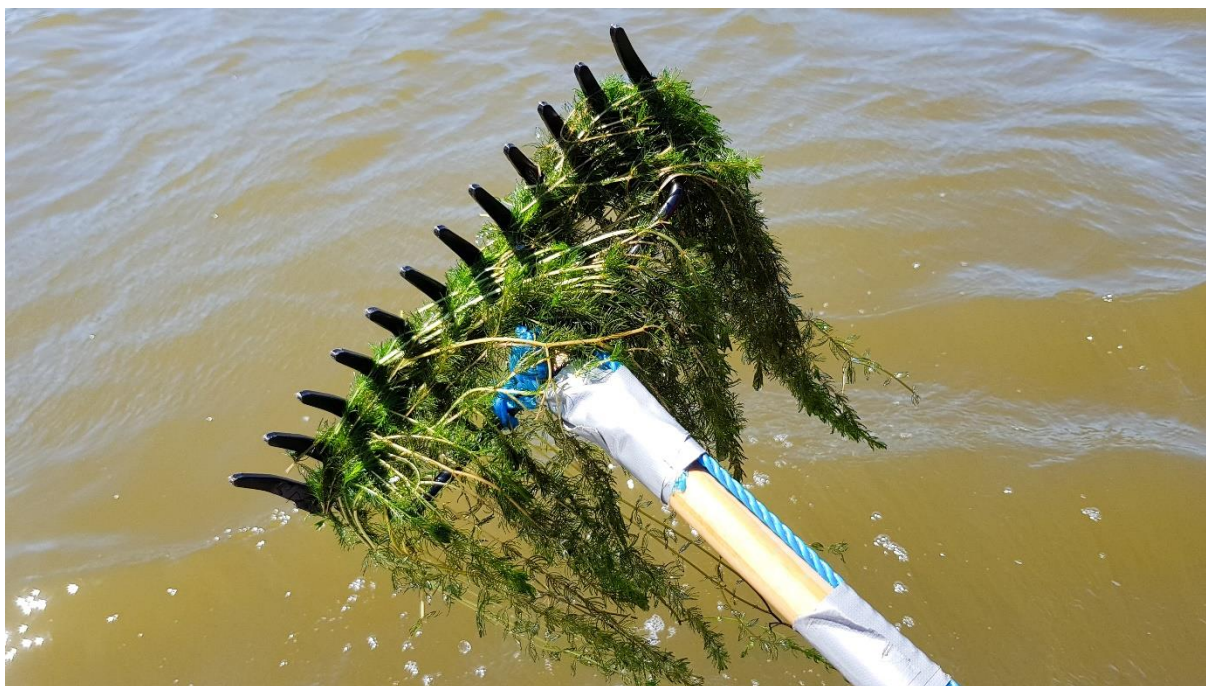
**Figure 35:** Native milfoils *Myriophyllum triphyllum*, formed moderate covers across the bottom of Lake Kaitoke.

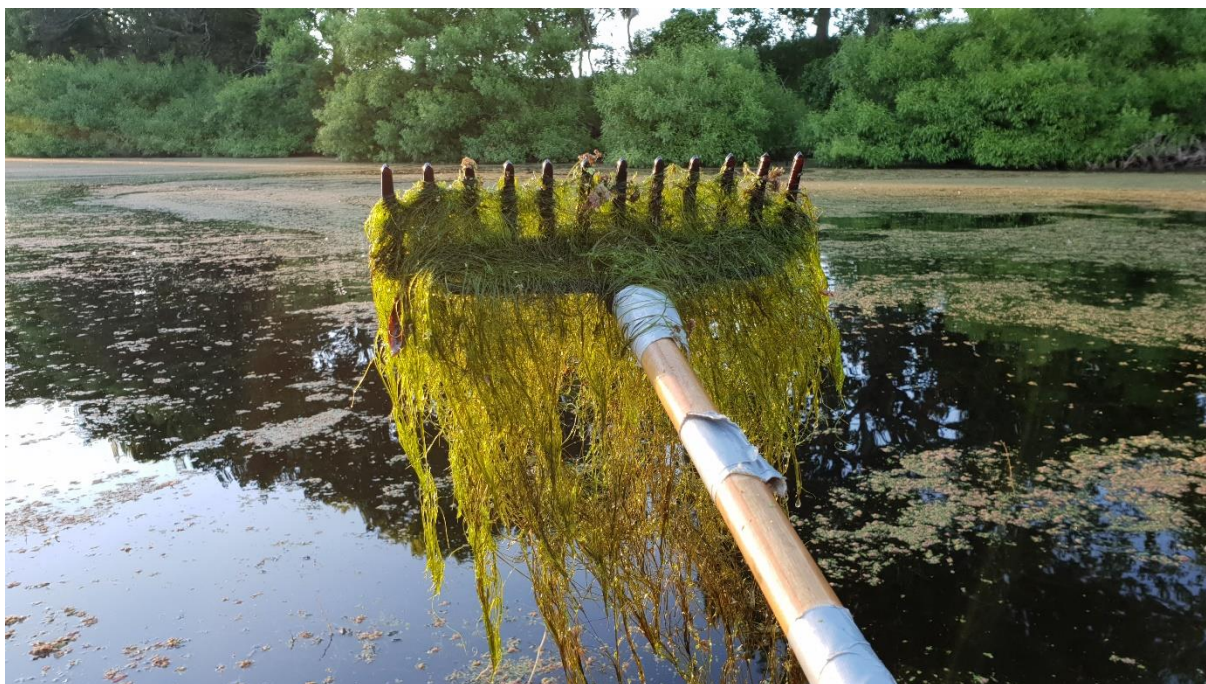
Native charophyte species *Nitella* sp. aff. *cristata*, formed meadows (> 75% cover) extending across the bottom of the lagoon at all four LakeSPI sites, to a maximum depth of 2.5 m (Figure 37). A native pondweed *Potamogeton ochreatus*, formed variable low to moderate covers, up to 1 m tall over the same 0.1 – 2.5 m depth range. Native milfoils *Myriophyllum propinquum* and *Myriophyllum triphyllum* were also recorded at two of the four sites close to the lake margin (c. < 0.8 m).

**Figure 37:** Charophyte meadows extended over the bottom of Karere Lagoon. Note, free-floating *Azolla rubra* accumulating on the lagoon surface.

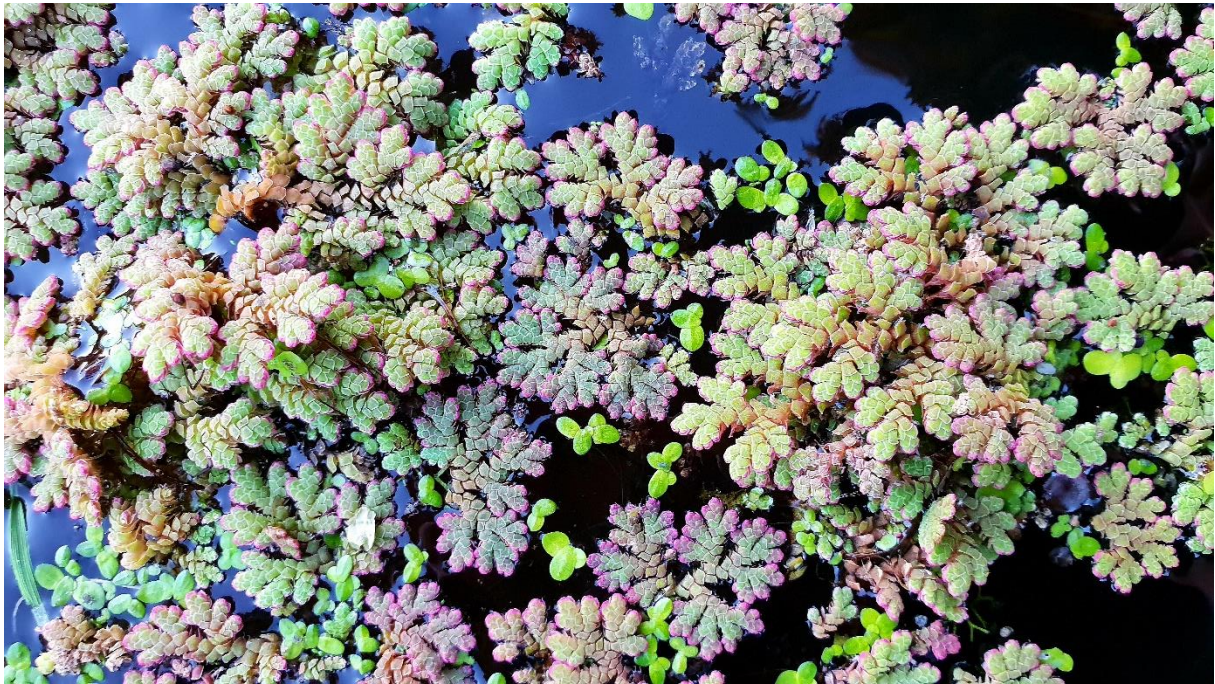
Three native free-floating species were present. Accumulations of the native fern *Azolla rubra* (Figure 38) formed extensive floating mats over much of the lagoon surface, particularly along the northern side and at each end of the oxbow. An aquatic liverwort *Riccia fluitans*, (Figure 39) and common duck weed *Lemna disperma* were also present recorded from all four sites.

**Figure 38:** Free-floating species *Azolla rubra* in Karere Lagoon. Smaller green leaves are *Lemna disperma*.

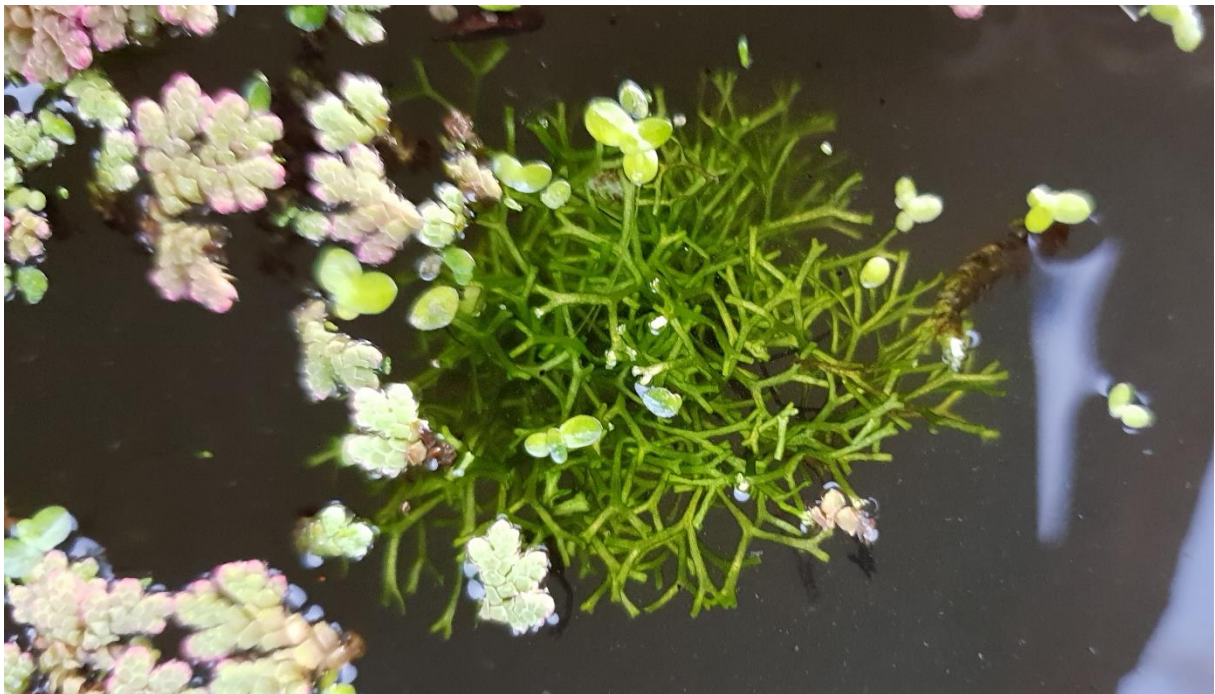
The floating crystalwort *Riccia fluitans*, (Figure 39) was an interesting find in the lagoon. It is one of the few true aquatic liverworts in New Zealand and was common at all sites.

**Figure 39:** Floating crystalwort (*Riccia fluitans*) formed bright green balls in Karere Lagoon. Seen here with other free-floating species *Azolla rubra* and *Lemna disperma*.

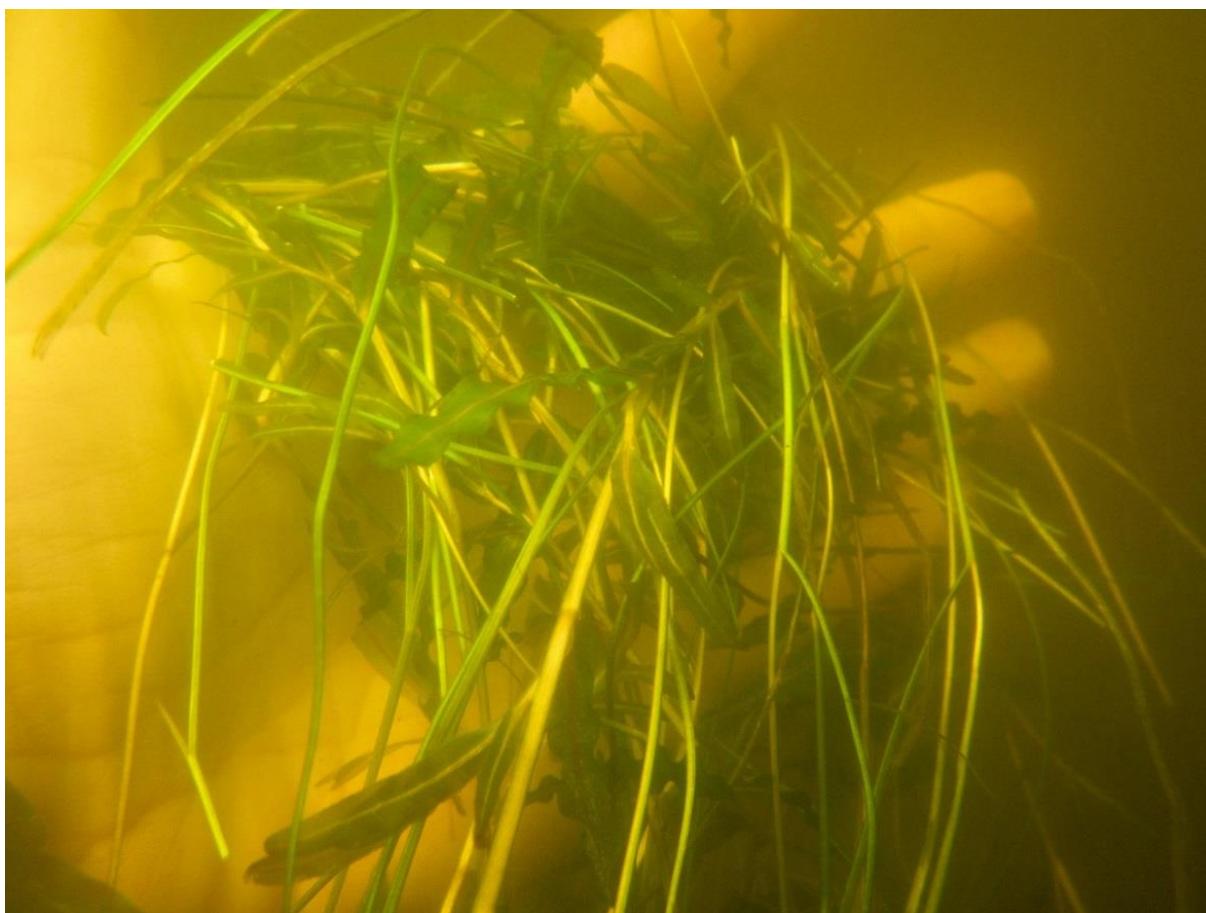
**Figure 47:** A handful of submerged vegetation comprising of a mix of native and introduced pondweed species growing across the bottom of Koputara.

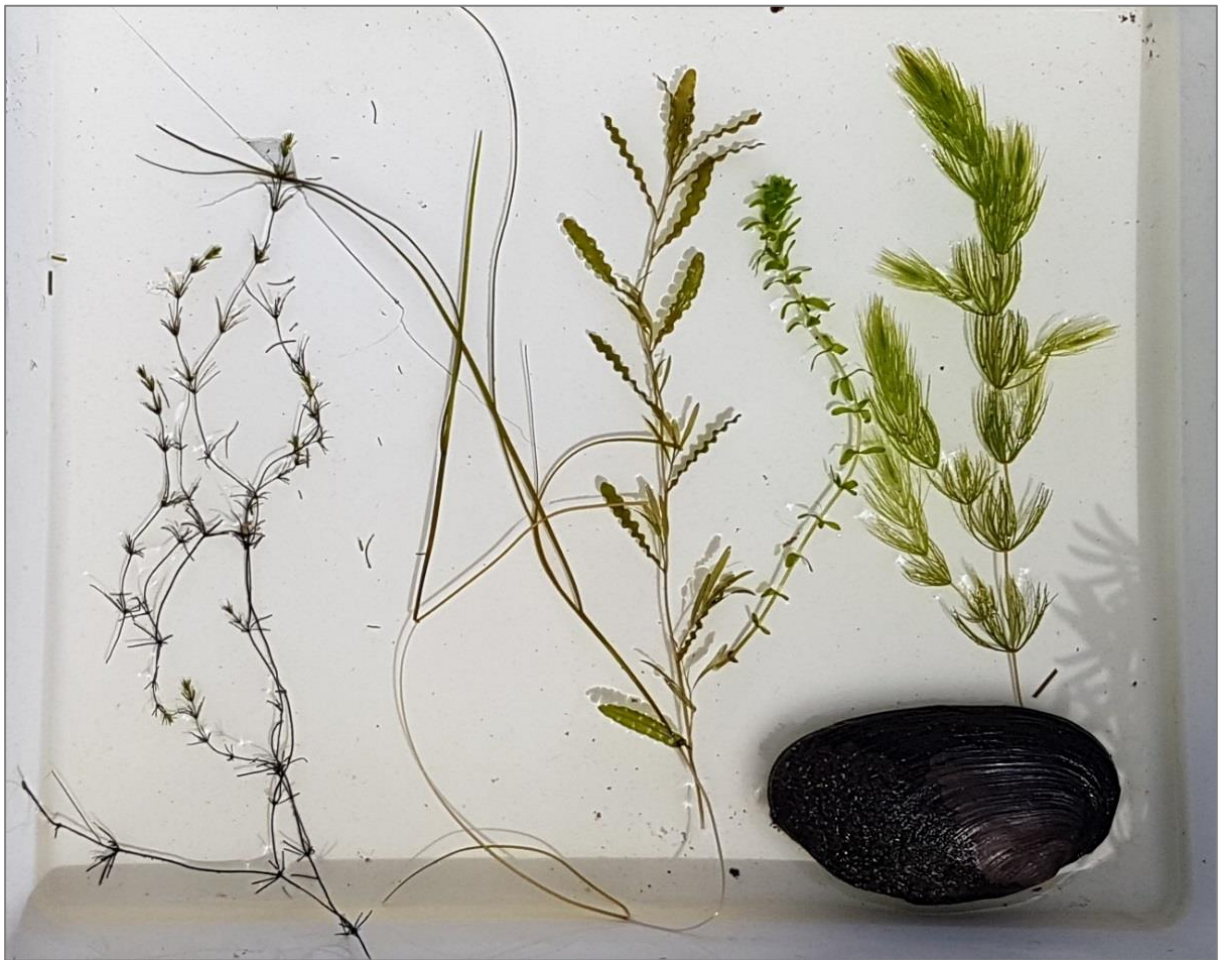
High densities of large freshwater mussels were observed within Lake Koputara with many measuring c. 100 mm in length. Examination of the shells suggests that these larger mussels (Figure 48) could be more than 50 years old (Sue Clearwater, NIWA, pers. comm.). The mussel shells in general were noted to be in good condition with no signs of erosion or deformities, suggesting that environmental factors for mussel populations in the lake were good.

**Figure 48: Plant species and mussel from within Lake Koputara.** From left to Right: native species: *Chara globularis* and *Ruppia polycarpa*; and invasive species: *Potamogeton crispus*, *Elodea canadensis*, and *Ceratophyllum demersum*.

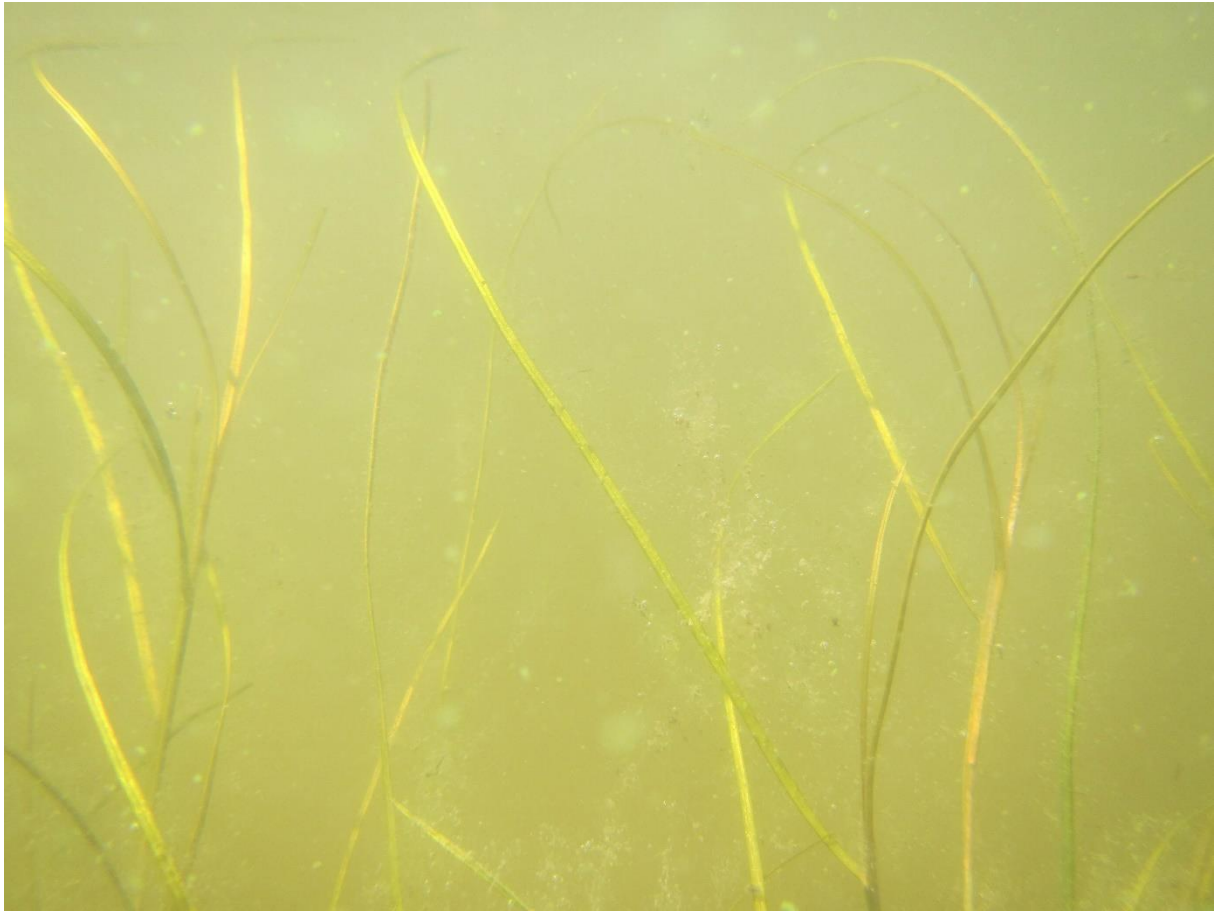
**Figure 50:** Native pondweed *Stuckenia pectinata* formed high covers across the bottom of Lake Mahangaiti.

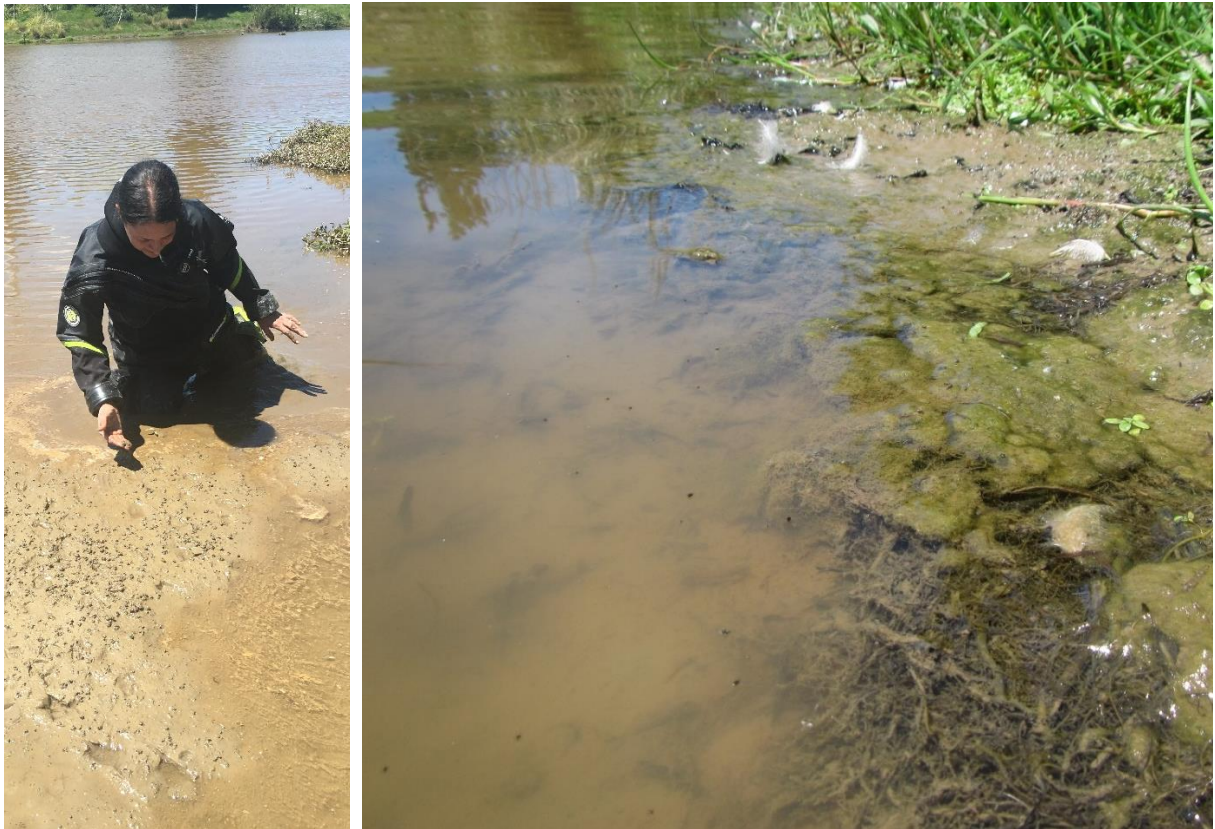
Access was restricted to the lake margin due the very soft, sludgy clay-like mud surrounding the lake. The water was very brown in colour and clumps of filamentous algae were common around the margin (Figure 52).

Poor water quality and the softness of the lake bottom make this lake unsuitable for submerged plant growth. The landowner described the bottom sediments to be like 'quicksand' and estimated the maximum lake depth to be < 2 m (J. Bolton, pers. comm.).

**Figure 52:** Manawatū Gorge Dam showing soft sludgy sediments and clumps of algae on the lake margin.
