# Assessment of 47 Lakes in the Manawatu-Whanganui Region using LakeSPI

NIWA CLIENT REPORT No: 2021157HN  
Report date: June 2021  
NIWA Project: HRZ19201

Horizons Regional Council contracted NIWA to report on the ecological condition of 47 lakes in the Manawatū-Whanganui region using LakeSPI (Submerged Plant Indicators). LakeSPI is a bioassessment method that uses the degree of development by native submerged plants, and level of impact by non-native, invasive weeds to indicate a lakes ecological condition. Lakes were assessed over five main survey occasions between November 2015 and December 2020. New or repeat surveys carried out for inclusion into this report included: Alice, Dudding, Centennial (Hokowhitu) Lagoon, Namunamu, Pauri, Pukepuke Lagoon, Virginia (Rotokawau), Waipu and Wiritoa.

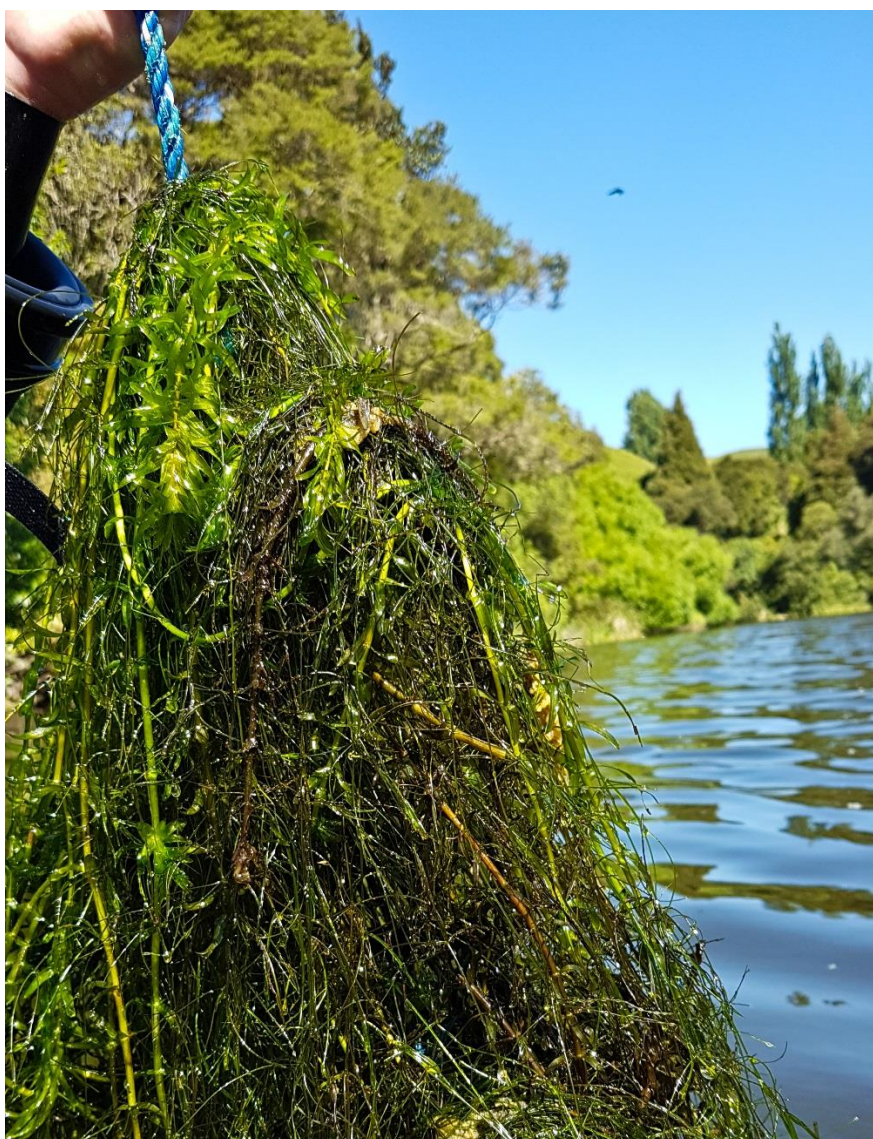
This lake had poor water quality at the time of the survey (November 2016) resulting from an algae bloom present in the lake. In conversation with a neighbouring farmer, they noted that the colour of neighbouring Lake Maungaratanui had likely changed only a couple of days prior to this visit. This observation would also be consistent with the survey results for Lake Maungarataiti too, as despite there being zero through-water visibility in the top few meters of water, a healthy submerged plant community (Figure 54) was present in the lake down to c. 5.5 m.

**Figure 54:** Submerged plants in Lake Maungarataiti consisted of the invasive weed egeria (top left) and native charophyte species (bottom right).

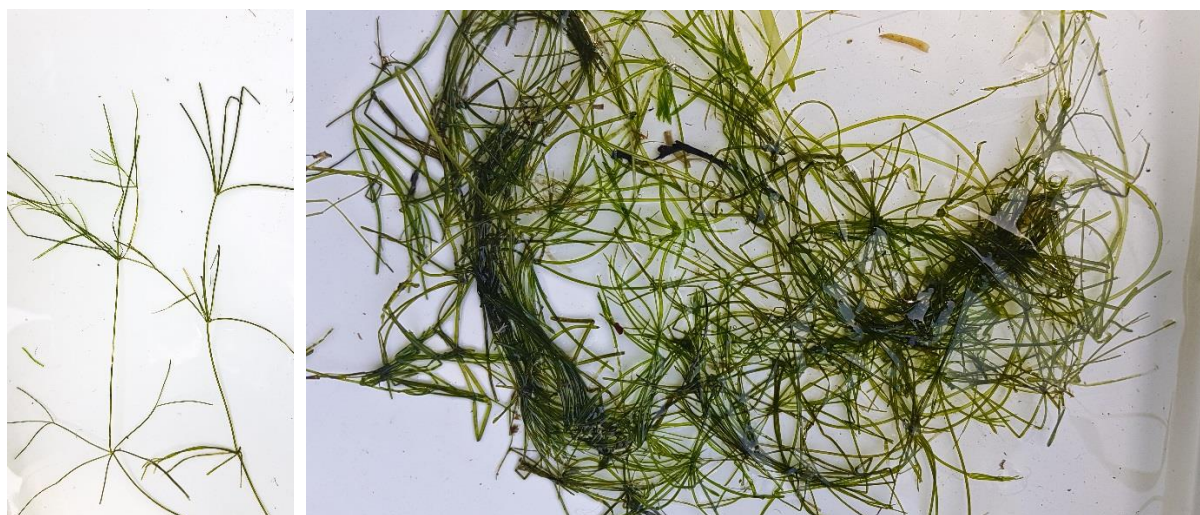
**Figure 56:** Native charophyte *Nitella* sp. aff. *cristata*, was recorded from two sites in Maungaratanui.

Native charophytes (*Nitella* sp. aff. *cristata* (Figure 56), *Chara australis*) were observed from two of the five LakeSPI sites, in shallow water (<2 m). The native pondweed *Potamogeton ochreatus* was also present at four of the baseline sites.

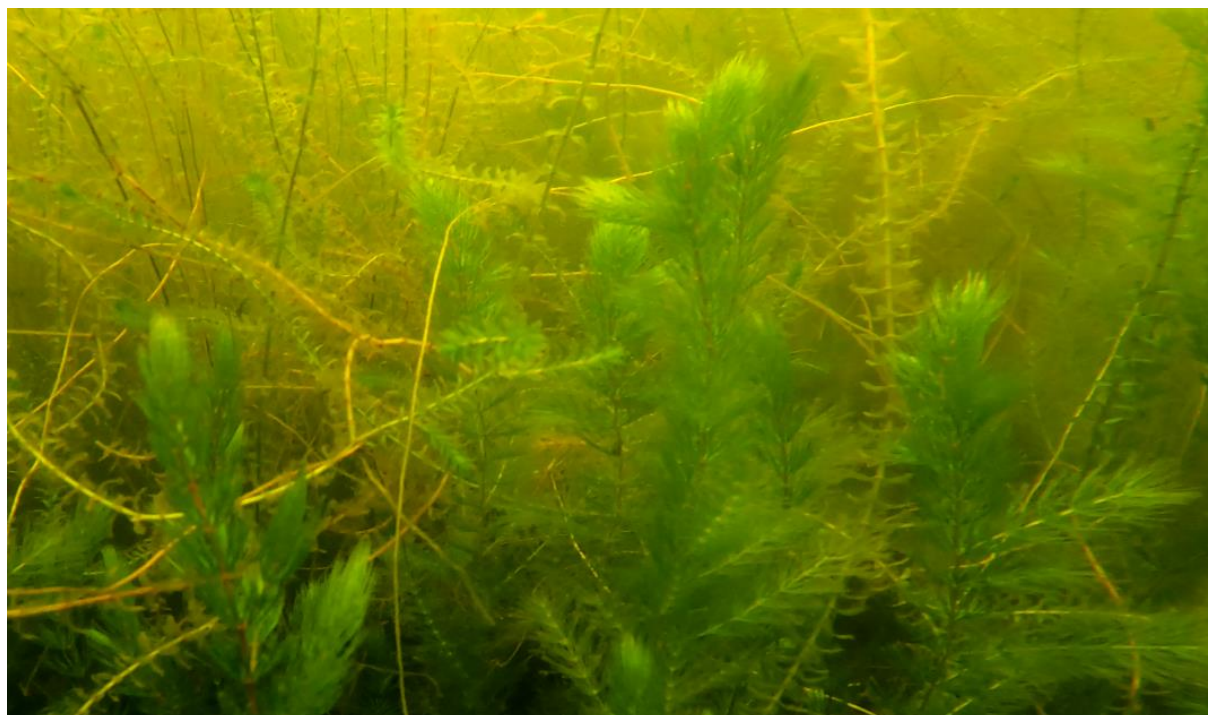
**Figure 60:** Hornwort (foreground) and Elodea growing in Lake Namunamu.

Hornwort (*Ceratophyllum demersum*) was first discovered in Lake Namunamu in May 2019 (Horizons Regional Council, Agenda Report for Environment-Committee, 14 August 2019), and during the December 2020 survey it was recorded from three of the five LakeSPI sites (Figure 60).

While the LakeSPI Index shows no significant change between the 2016 and 2020 timeframe (Figure 59), an increase in the Invasive Impact Index from 74% in 2016 to 79% in 2020 reflects the early stages of invasion by hornwort in this lake. It is expected that the Invasive Impact scores for Lake Namunamu will increase significantly as hornwort continues to spread and expand its reach around the lake, particularly into deeper water where it has the potential to displace all remaining native vegetation. Currently elodea (*Elodea canadensis*) forms a band of weed around the lake margin extending down to a maximum depth of 5.3 m, thus allowing charophytes to grow beyond this depth to a maximum depth of 6.8 m. During the 2020 survey hornwort was recorded growing down to 6.4 m and 6.8 m at two of the sites. It is likely that hornwort will displace all remaining native vegetation, in particular the deeper growing charophytes within the next few years.

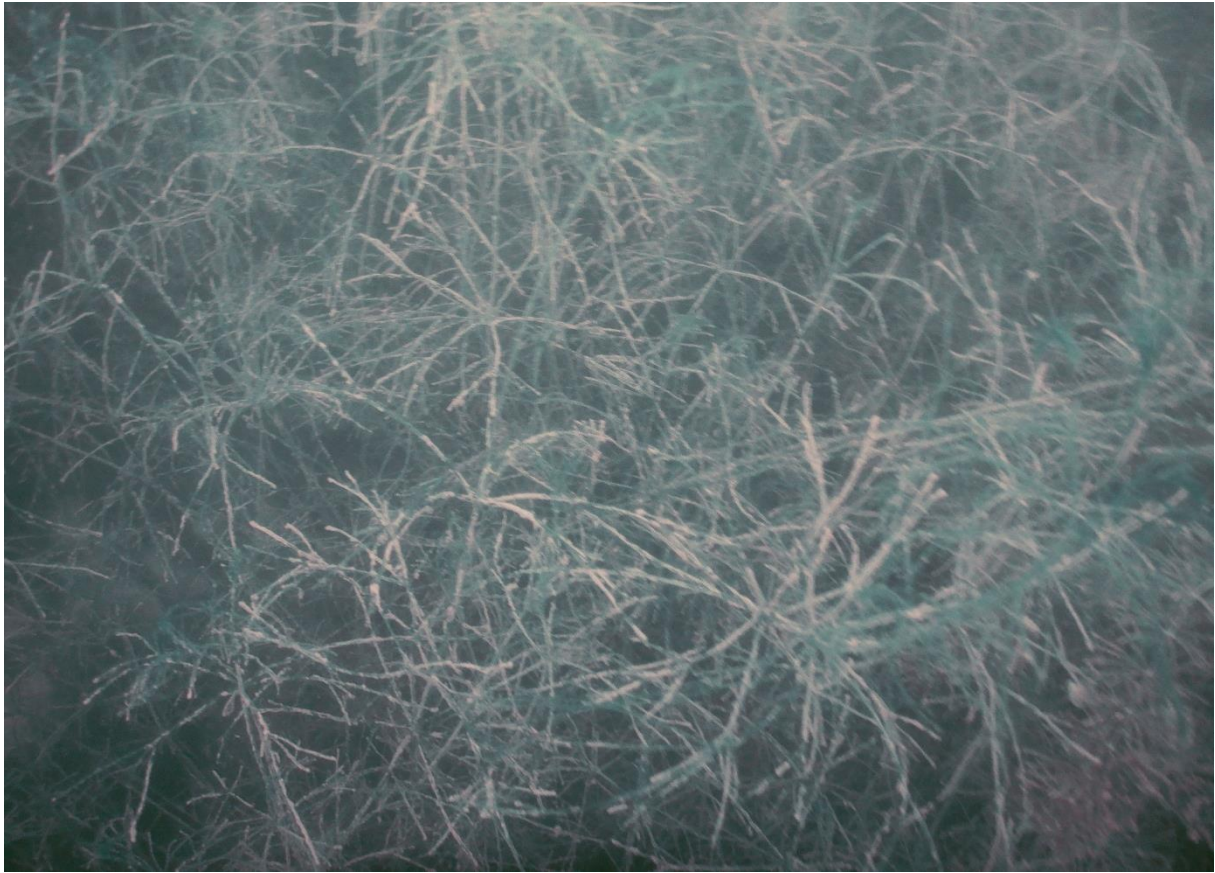
**Figure 61:** Native charophytes (*Nitella* sp. aff. *cristata*) in Lake Namunamu .

Charophytes were present at all five sites and formed meadows (>75% cover) at four sites extending beyond the elodea weed beds to a maximum depth of 6.8 m. Flowering stems of the native milfoil *Myriophyllum triphyllum* were also observed elsewhere in the lake but not at a LakeSPI site.

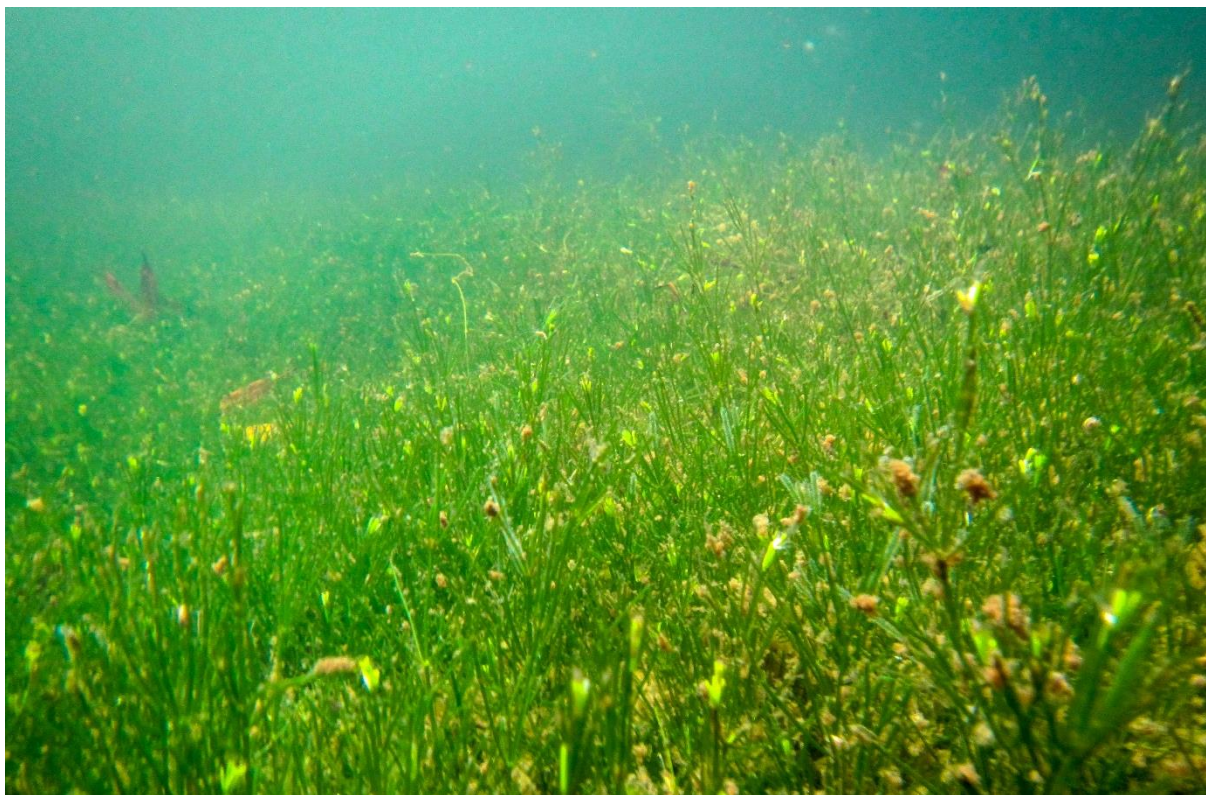
**Figure 66:** A native charophyte *Nitella sp. aff. cristata*, formed meadows in Ohinetonga Lagoon.

Charophyte species *Nitella* sp. aff. *cristata*, formed dense meadows (> 75% cover) at all five LakeSPI sites extending across the bottom (Figure 66) to a maximum depth of 2.7 m. The native pondweed *Potamogeton ochreatus*, was the only other submerged plant growing in the lagoon and it formed tall patches, up to 2.4 m tall, from a depth of c. 1 – 2.7 m at all sites (Figure 67).

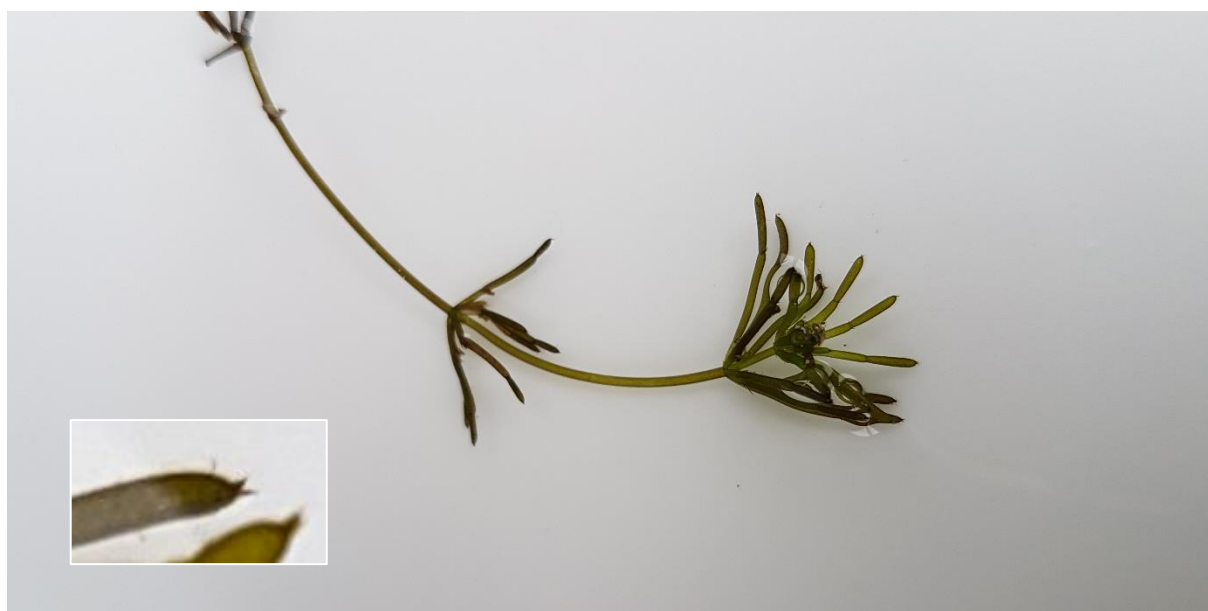
**Figure 70:** *Chara* sp. aff. *muellerii* from Omanuka Lagoon. Insert shows distinctive tips with two end cells.

An exciting find in Omanuka lagoon was the discovery of the native charophyte species, *Chara* sp. aff. *muellerii* (Figure 70), for the first time in the North Island. This plant's threat status is categorised as data deficient (Townsend et al. 2008), and it is thought to be at risk (Paul Champion, NIWA, pers. comm.).

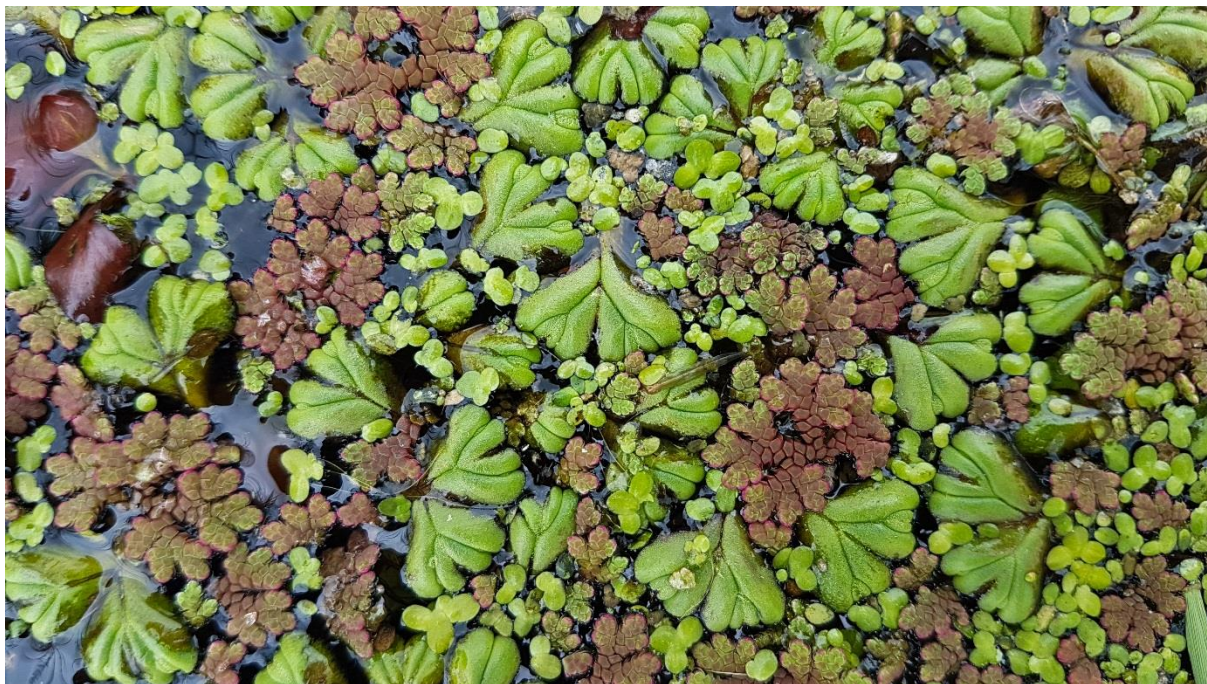
**Figure 71:** *Ricciocarpos natans* (bigger green leaves) growing amongst other free-floating species (*Azolla rubra* (reddish colour) and *Lemna disperma*) in the Omanuka Lagoon.

Another plant of interest was the near-threatened (At Risk: Declining – de Lange et al. 2020) aquatic liverwort, *Ricciocarpos natans* (Figure 71). This free-floating species was found growing amongst another free-floating native species in sheltered areas around the margin.

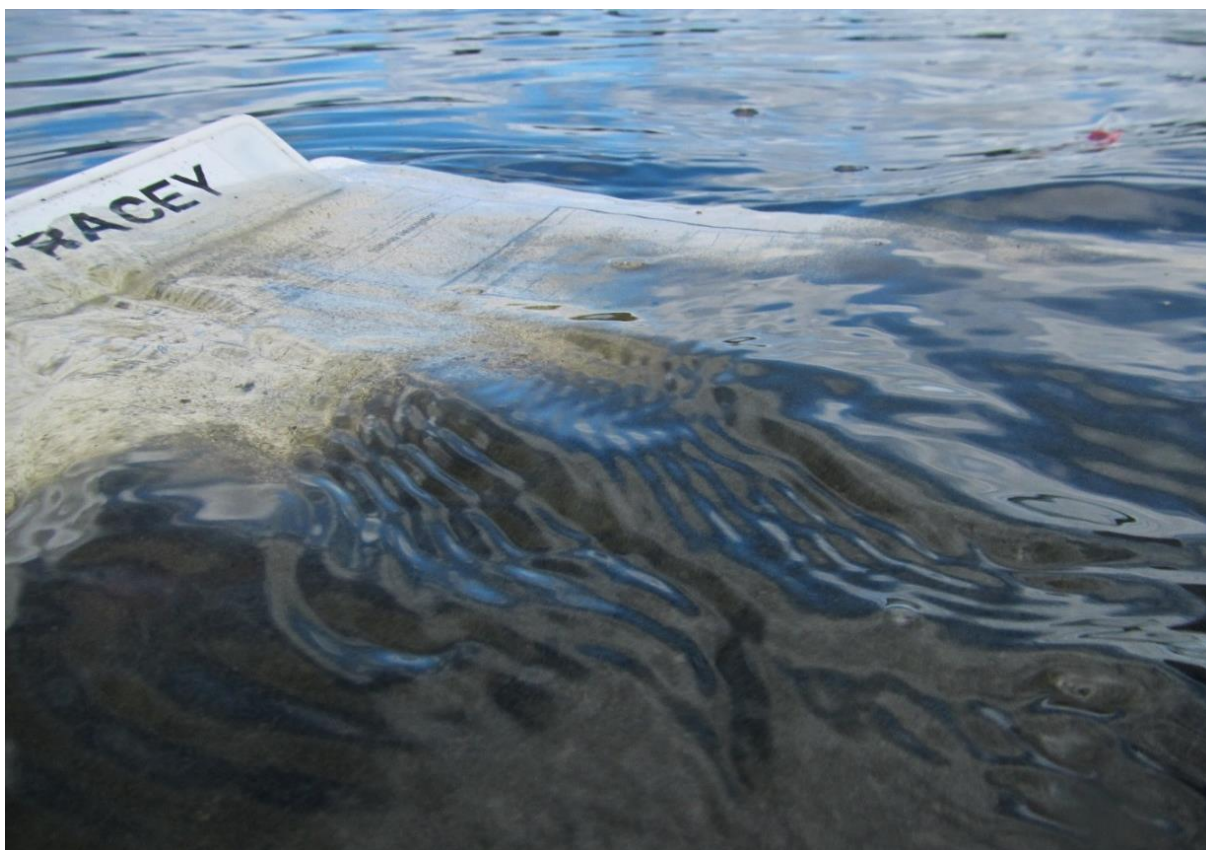
**Figure 79:** Clipboard on the surface of Lake Papaitonga shows the colour of water and range of visibility.

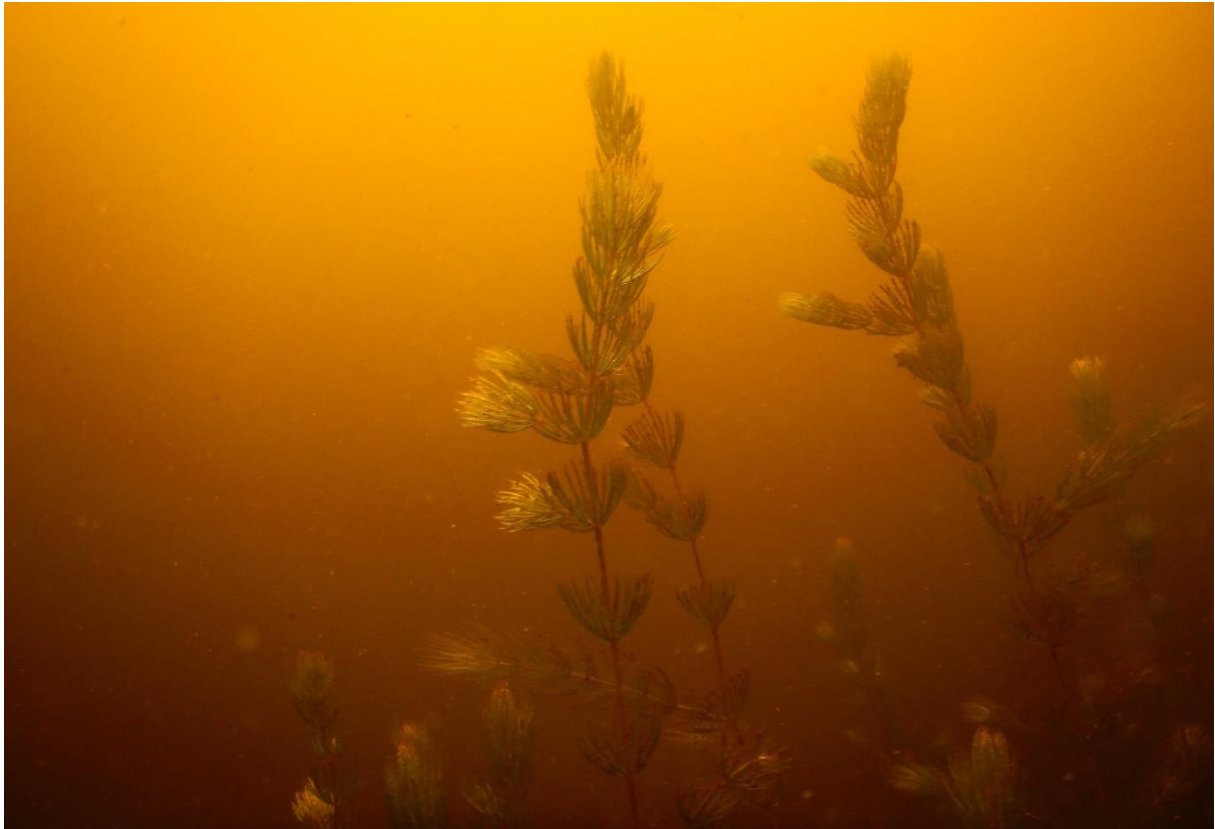
**Figure 81:** Hornwort dominated the vegetation in Lake Pauri.

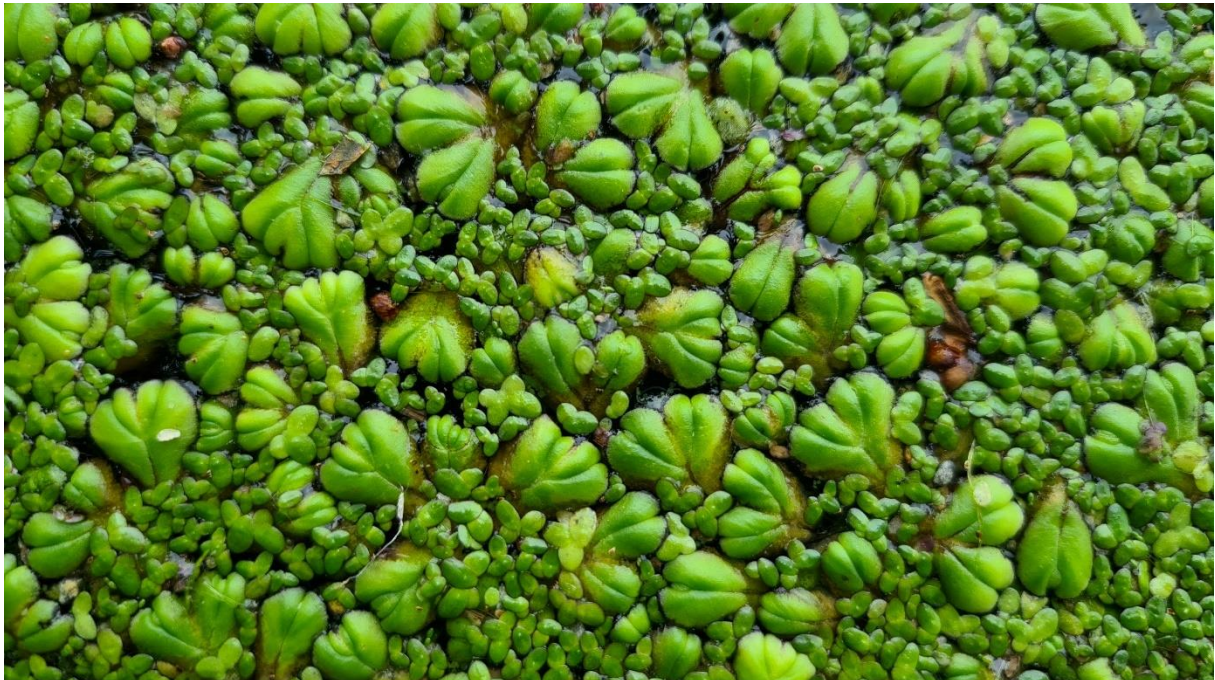
**Figure 82:** Native free-floating *Ricciocarpus natans* (bigger leaves) growing amongst *Lemna disperma*

A near-threatened (At Risk: Declining – de Lange et al. 2020) aquatic free-floating liverwort, *Ricciocarpos natans* (Figure 82) was also recorded from the lake. This free-floating species was observed growing amongst other free-floating native species, *Azolla rubra* and *Lemna disperma* in sheltered areas around the jetty close to the sailing club.

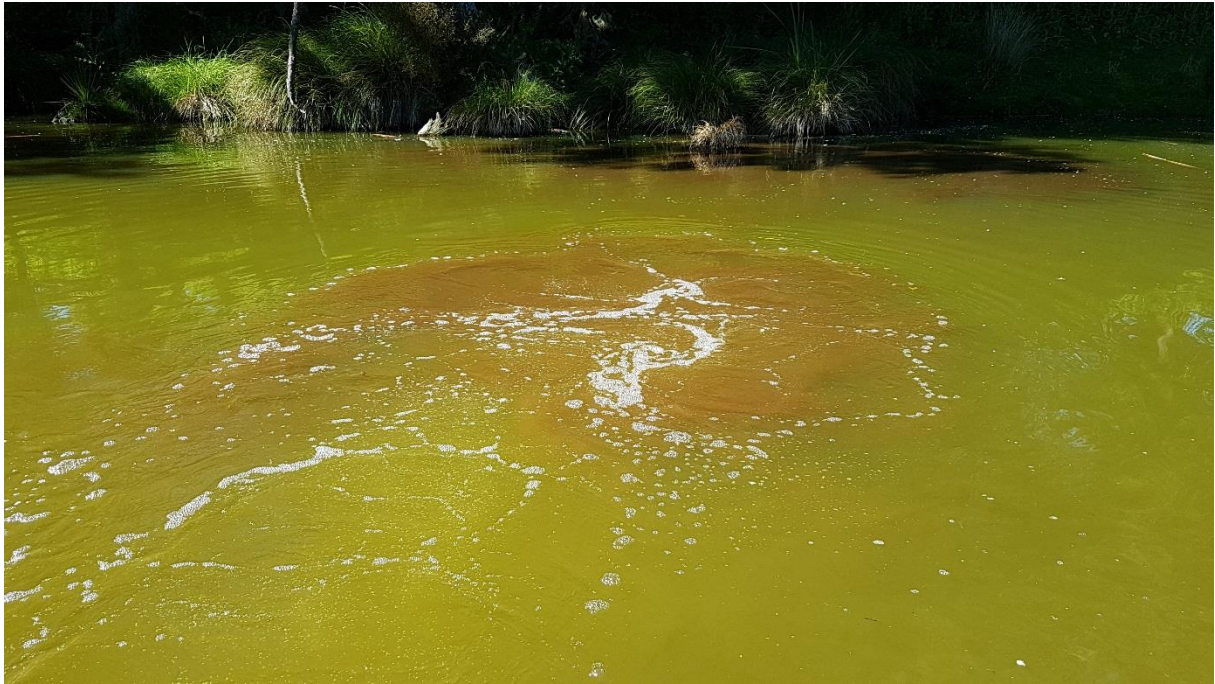
**Figure 84:** The lake water appeared yellow in Lake Poroa at the time of the survey. The browner water in the centre shows disturbance of the sediments by the boat prop.

At the time of this recent survey, the water was noted to be a yellow-brown colour (Figure 84), with little underwater visibility. Secchi disk reading was 0.3 m. No freshwater mussels were observed.

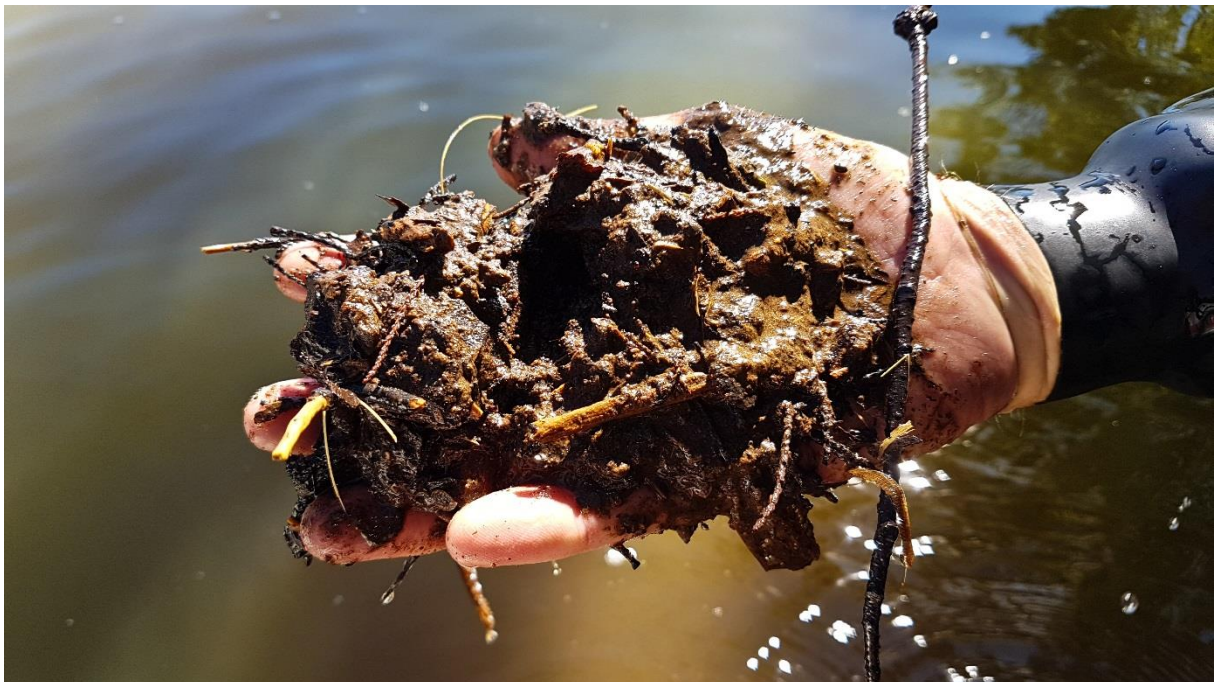
**Figure 85:** Lake Poroa had soft organic bottom sediments.

This lake had extremely low water clarity and bottom sediments were a soft sludge (Figure 85) making this lake unsuitable for submerged plant growth.

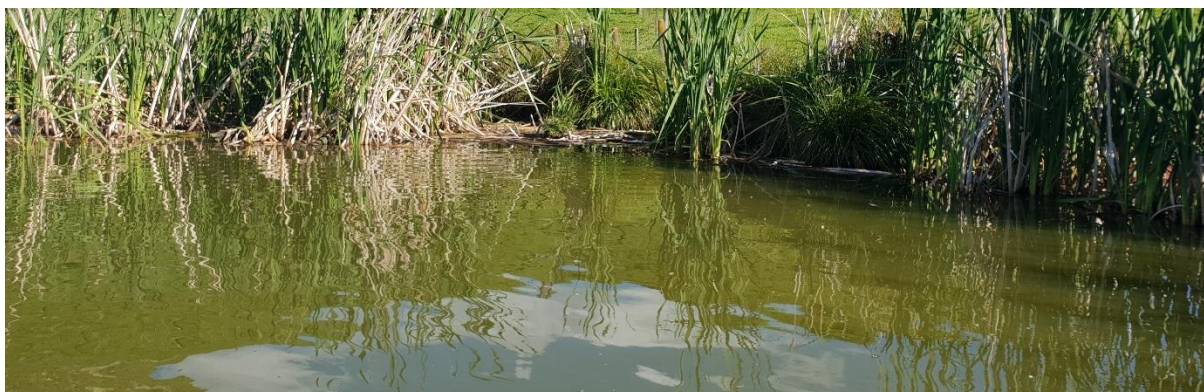
**Figure 87:** Lake Pounamu was green during the 2018 survey.

No submerged plants were present in the lake. At the time of the survey, a dense algae bloom was present, and the water was very green in colour (Figure 87).

Submerged vegetation noted in the lagoon in 2003 (Champion and Wells 2003) was not present during the recent survey. Poor water quality noted at the time of the recent survey likely makes this lake unsuitable for submerged plant growth.

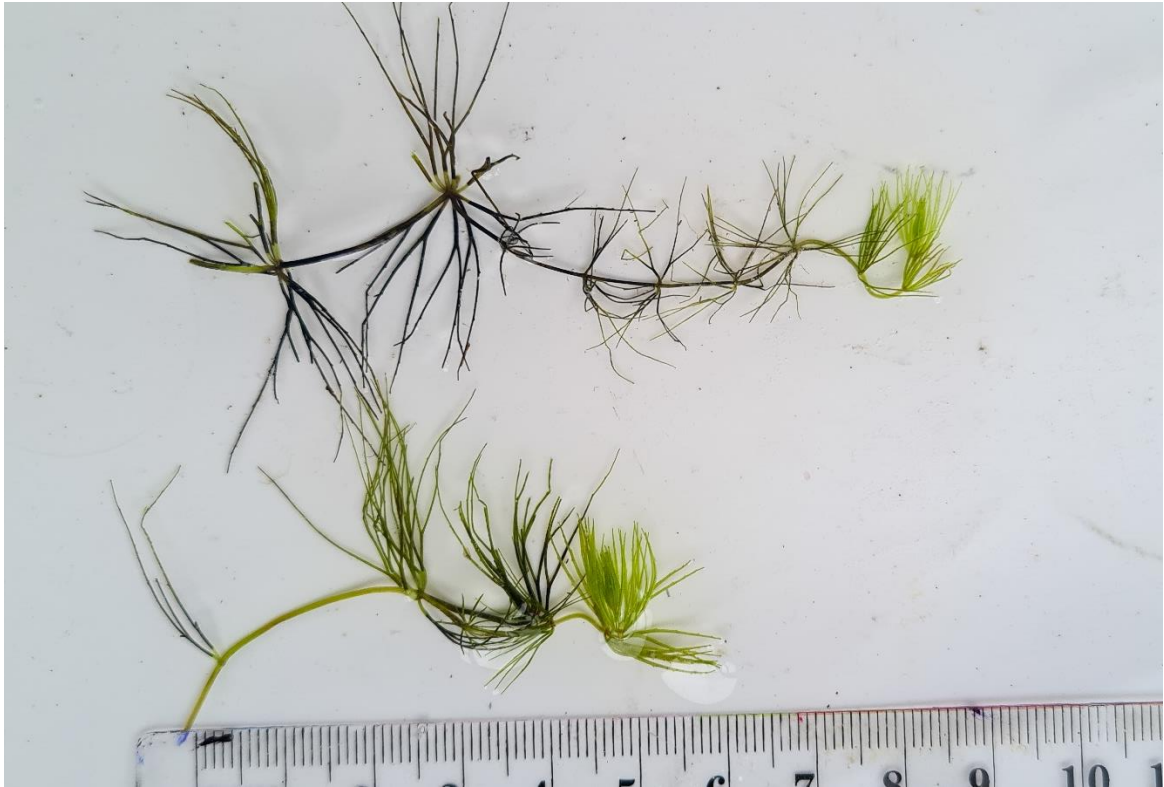
**Figure 89:** Hornwort fragments found in Pukepuke Lagoon during the 2020 survey.

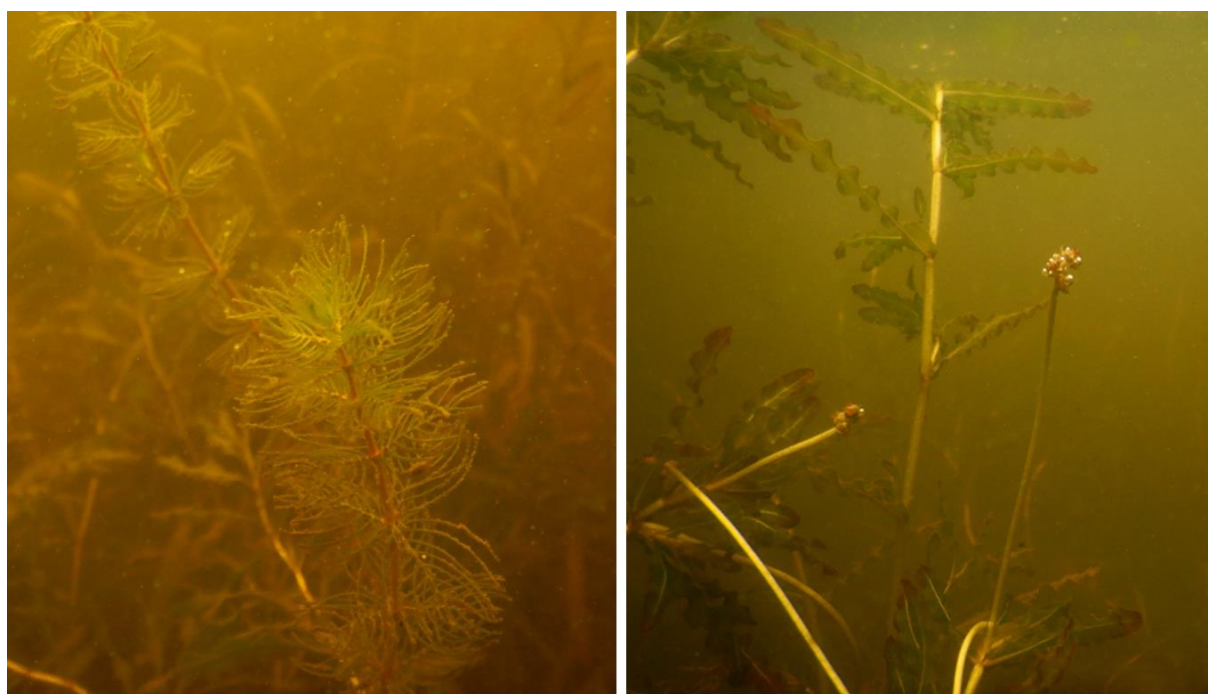
**Figure 97:** Native milfoil *Myriophyllum triphyllum* (left) and the introduced pondweed *Potamogeton crispus* (right) in Lake Rotokauwau.

Native vegetation consisted of four charophytes (*Chara australis*, *Chara globularis*, *Nitella* sp. aff. *cristata*, *Nitella stuartii*), three tall native vascular plants (*Potamogeton ochreatus*, *Stuckenia pectinata*, *Myriophyllum triphyllum* (Figure 97) and a turf forming species *Glossostigma elatinoides*. Charophyte meadows (>75% cover) were observed over much of the lake bottom at four of the five LakeSPI sites.

The introduced pondweed *Potamogeton crispus* (Figure 97) was the most prevalent introduced species in the lake. It formed high but variable covers across the bottom at all five sites. *Egeria* (*Egeria densa*) was recorded from one site forming small clumps, up to 0.6 m high, between 1.2 – 1.6 m depth.

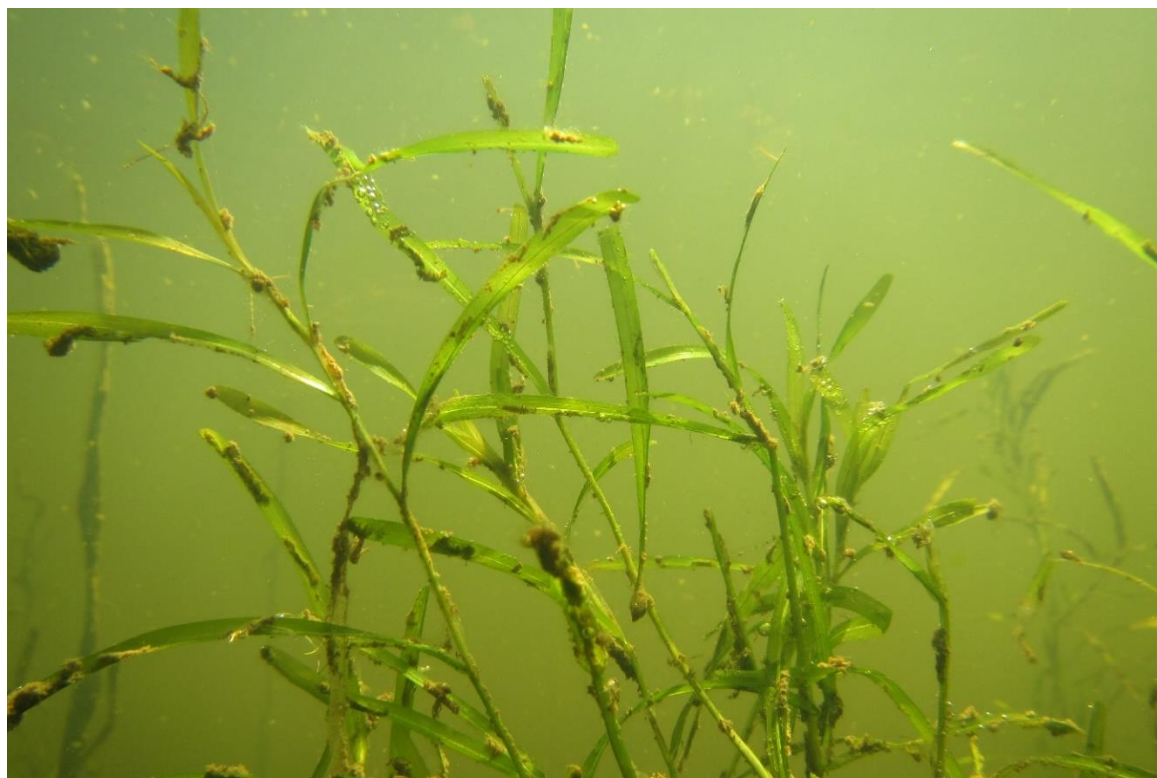
**Figure 99:** Native pondweeds (*Potamogeton ochreatus*) in Lake Rotorua.

Native pondweed *Potamogeton ochreatus*, formed moderate to high covers at all five LakeSPI sites, growing up to 1.6 m tall and extending down a maximum depth of 3 m (Figure 99). A native charophyte *Chara australis*, was also present, generally at low covers in the shallows (< 1 m), but was meadow forming (> 75% cover) at one site (Figure 100). Other native species included two free-floating species *Azolla rubra* and *Lemna disperma*. *Azolla* formed a dense floating mat along the western margin of the lake.

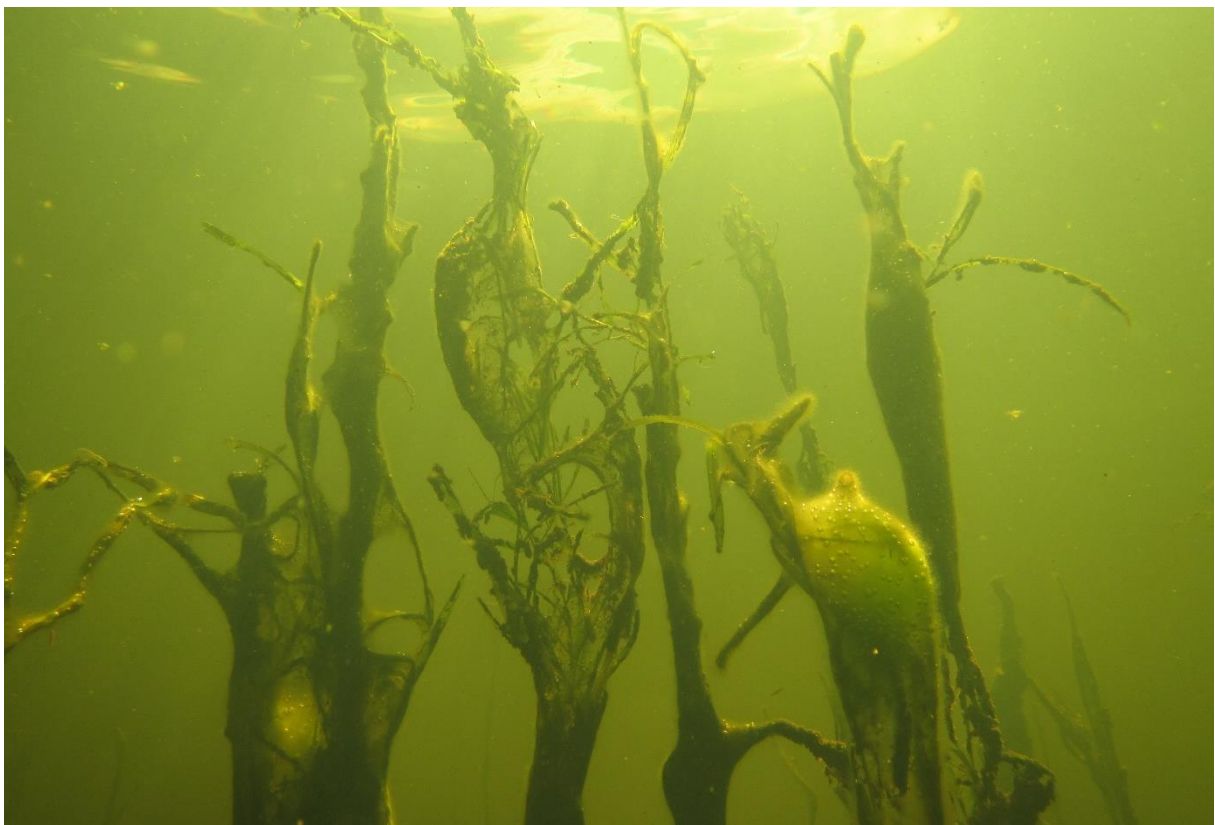
**Figure 101:** A thick layer filamentous algae covered the plants in Lake Rotorua.

At the time of recent survey, through-water visibility was good and estimated by divers to be c. 3.0+ m. A thick layer of filamentous algae (Figure 101) was noted covering most plants. No freshwater mussels were observed.

A high LakeSPI Index of 56% (Figure 98) reflects the presence and extent of native species in the lake with only limited impact from invasive species. The native pondweed *Potamogeton ochreatus* was the most prevalent species recorded with plants appearing healthy at the time of the recent survey (early summer). As pondweeds are seed and turion (specialised asexual reproductive organs similar to tubers) producing species, should lake conditions become unfavourable for plant growth (e.g., due to water quality), they have the ability to recolonise once conditions for plant growth improve. This may explain observations from the visit (Champion and Wells 2003) in late summer, which noted that the pondweeds appeared to have died off with only seedlings persisting. A thick layer of filamentous algae covering the plants at the time of the recent survey likely indicates ongoing issues with water quality in the lake.

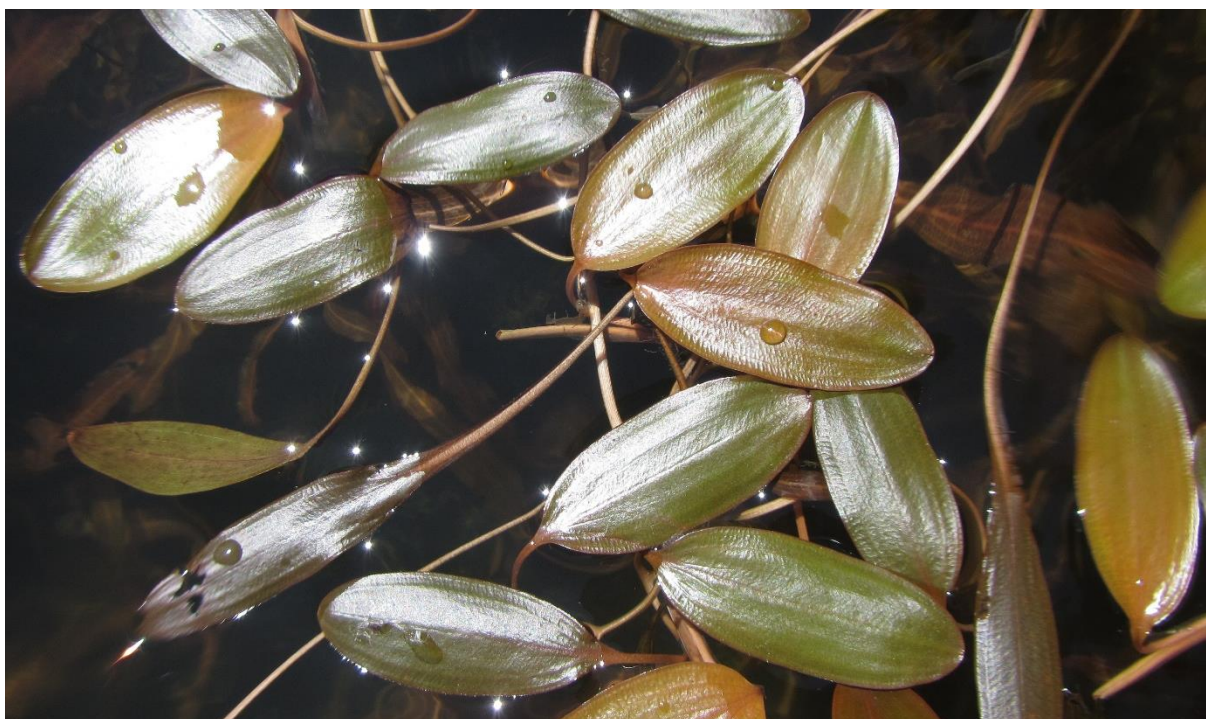
**Figure 104:** Surface floating leaves of the pondweed *Potamogeton cheesemanii* on the Saddle Road Dam.

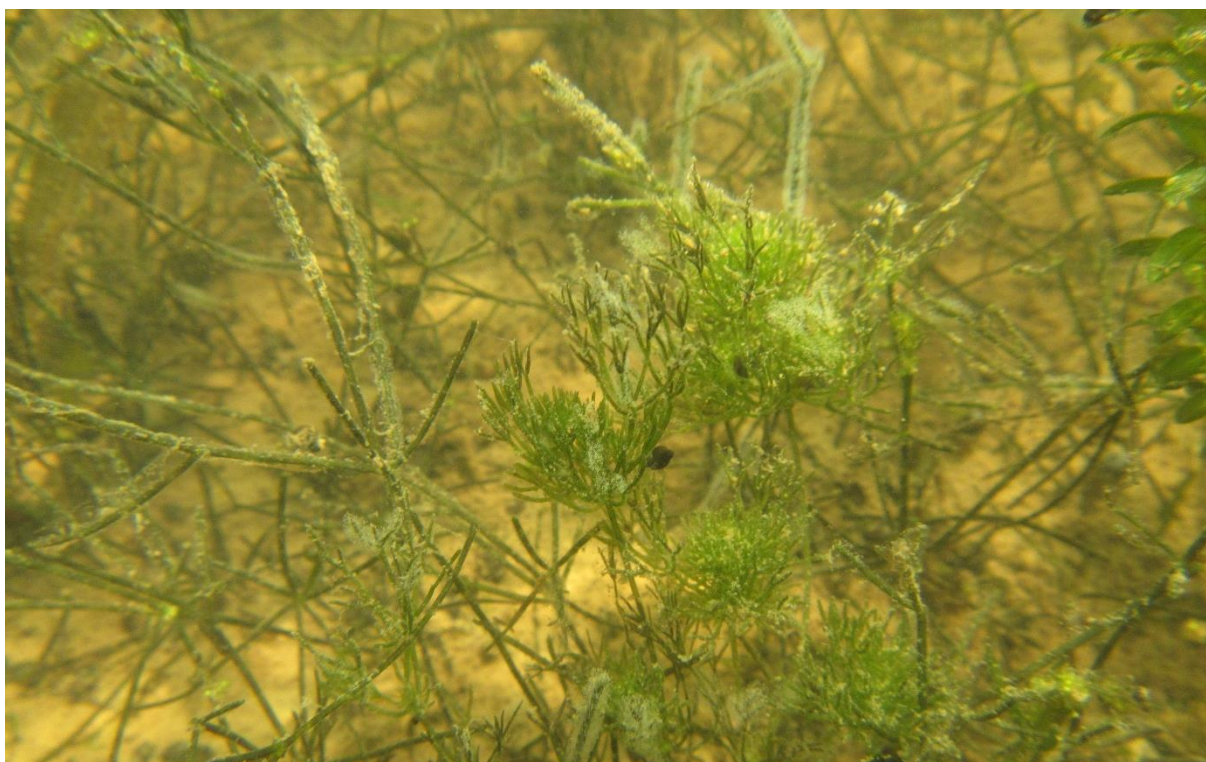
**Figure 105:** Native charophytes *Chara australis* (background) and *Nitella stuartii* (middle front) were recorded on the southern side of the Saddle Road Dam.

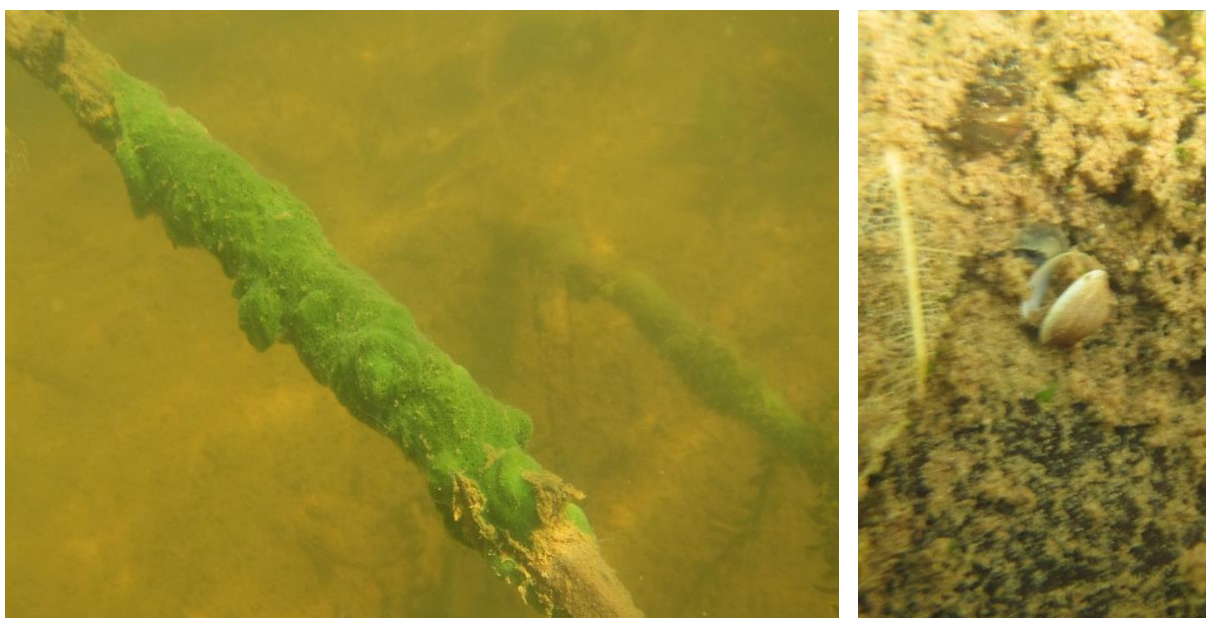
**Figure 106:** Freshwater sponges (left) and fingernail clams (right) were common in the Saddle Road Dam.

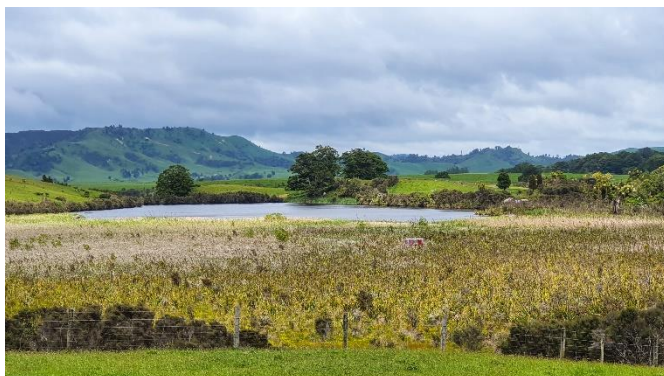
Lake condition:	Excellent
Lake ranking:	9 <sup>th</sup> equal
Lake maximum depth:	6.2 m
Max depth of vegetation:	2.3 m

**Figure 107: LakeSPI results for Te Paata Wetland.** LakeSPI Indices expressed as a percentage of lake maximum potential.

Te Paata Wetland is categorised as being in excellent condition with a LakeSPI Index of 78% (Figure 107).

The Te Paata Wetland lake sits just above the cusp of being classified in excellent condition with a LakeSPI Index of 78% and Native Condition Index of 56% (Figure 107). These high scores reflect the presence of native charophyte meadows (> 75% covers) and pondweeds around the lake and the absence of any introduced species.

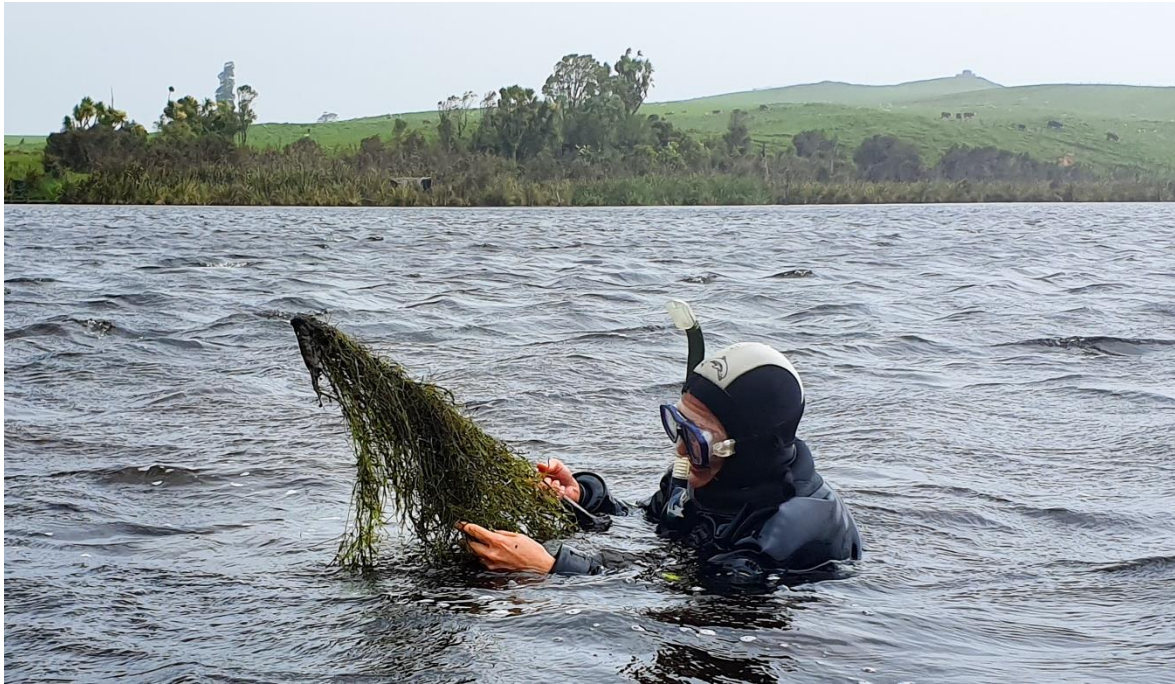
Two native charophyte species (*Nitella* sp. aff. *cristata* and *Chara australis*) were recorded from the lake. *Nitella* sp. aff. *cristata* (Figure 108) was the most abundant and it formed meadows (>75% cover) at all five LakeSPI sites extending from the shallows down to a maximum depth of 2.3 m. A native pondweed, *Potamogeton ochreatus*, was recorded forming low to moderate covers at three of the five sites.

**Figure 108: Native charophytes formed high covers around the margins of Te Paata Wetland Lake.**

While threats from invasive weed species appear minimal on account of restricted public access into the wetland, it is advisable that the land owners be notified to exercise discretion in allowing access to the lake for users of equipment that may be contaminated with invasive species (e.g., boats used for duck shooting, eel fishing nets).

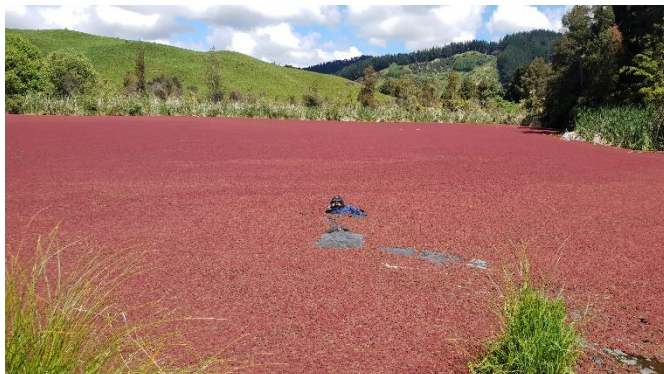
Lake condition:	Excellent
Lake ranking:	5 <sup>th</sup>
Lake maximum depth:	4.5 m
Max depth of vegetation:	3.1 m

Survey Date	Status	LakeSPI %	Native Condition %	Invasive Impact %
November 2018	Excellent	90% <div><div></div></div>	77% <div><div></div></div>	0%

**Figure 109: LakeSPI results for Twin Lakes.** LakeSPI Indices expressed as a percentage of lake maximum potential.

The eastern basin of the Twin Lakes was categorised as being in excellent ecological condition with a LakeSPI Index of 90% (Figure 109).

A high Native Condition Index of 77% (Figure 109) reflected the presence of charophytes forming high covers over most of the lake bottom to 3.1 m, close to the lakes maximum depth of 4.5 m.

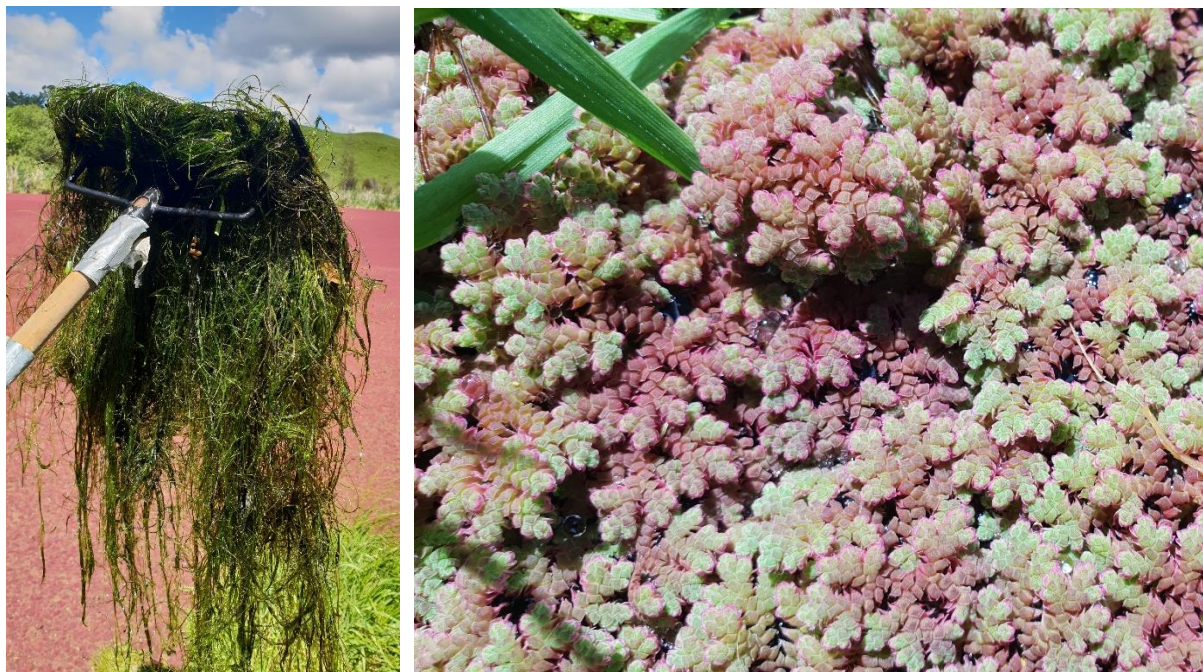
A free-floating native fern, *Azolla rubra* (Figure 110), was present covering the surface of Twin Lakes at the time of the survey. Below, a native charophyte *Nitella* sp. aff. *cristata*, formed a meadow (>75% cover) across the lake bottom extending down to a maximum depth of 3.1 m. No other submerged plant species were observed. A small patch of water lilies (*Nymphaea* species) were recorded from one of the four LakeSPI sites.

**Figure 110:** Native charophytes (left) formed high covers across the bottom of Twin Lakes below a floating mat of *Azolla rubra* (right).

Shading from the accumulation of azolla on the surface did not appear to be having an impact on submerged plant growth at the time of the survey (early summer). Azolla is common in shallow eutrophic water bodies such as farm dams and often dies back in winter.
