# Assessment of 47 Lakes in the Manawatu-Whanganui Region using LakeSPI

NIWA CLIENT REPORT No: 2021157HN  
Report date: June 2021  
NIWA Project: HRZ19201

Horizons Regional Council contracted NIWA to report on the ecological condition of 47 lakes in the Manawatū-Whanganui region using LakeSPI (Submerged Plant Indicators). LakeSPI is a bioassessment method that uses the degree of development by native submerged plants, and level of impact by non-native, invasive weeds to indicate a lakes ecological condition. Lakes were assessed over five main survey occasions between November 2015 and December 2020. New or repeat surveys carried out for inclusion into this report included: Alice, Dudding, Centennial (Hokowhitu) Lagoon, Namunamu, Pauri, Pukepuke Lagoon, Virginia (Rotokawau), Waipu and Wiritoa.

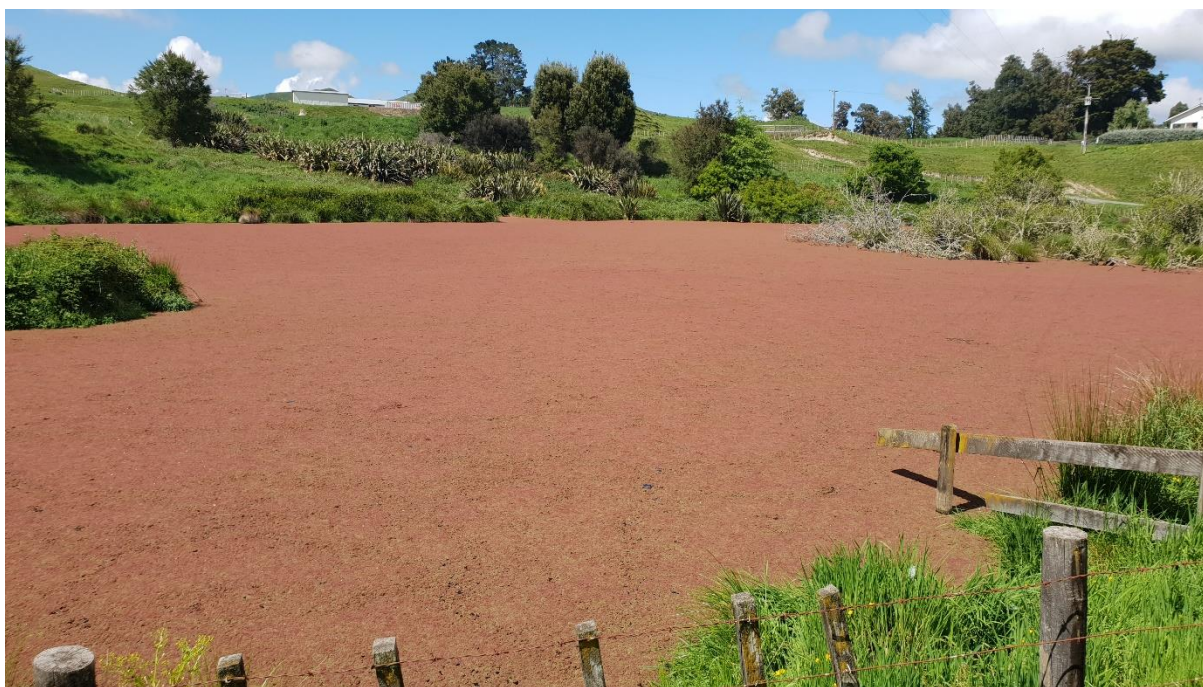
**Note:** Twin Lakes were comprised of two small water bodies separated by an earth dam. Both lakes were surveyed but only the deeper, eastern basin was considered appropriate for a LakeSPI assessment with results included above. The western basin (Figure 111) of Twin Lakes was very shallow at the time of the survey (< 0.9 m deep) but contained the same composition of submerged plants as the deeper Eastern basin. Native charophyte *Nitella* sp. aff. *cristata*, formed high covers across the lake bottom, growing below a floating mat of *Azolla rubra*.

**Figure 111:** Twin lakes western basin showing the accumulation of Azolla on the lake surface.

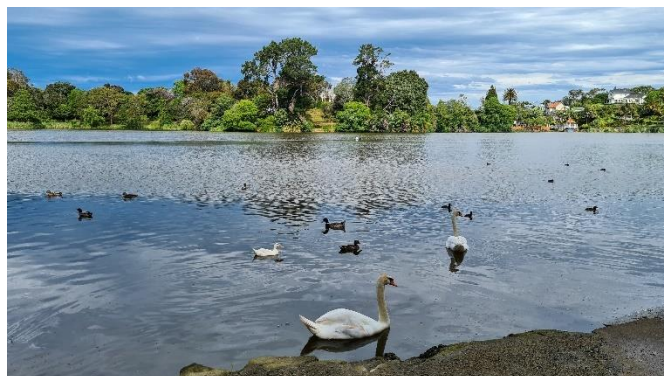
Lake condition:	Moderate
Lake ranking:	24 <sup>th</sup>
Lake maximum depth:	16 m
Max depth of vegetation:	6.2 m

**Figure 112: LakeSPI results for Lake Virginia.** LakeSPI Indices expressed as a percentage of lake maximum potential.

Lake Virginia is categorised as being in moderate ecological condition with a LakeSPI Index of 36% (Figure 112).

Despite the poor water quality encountered during the 2020 survey, and the long-term presence of egeria (for at least 17 years), the lake appears to have maintained a well-developed submerged native plant community. An Invasive Impact Index of 58% (Figure 112) is less than what could be expected for a lake impacted by egeria. It is most likely that the steep marginal zone noted in some areas around the lake, in combination with environmental conditions (e.g., water quality), prevent egeria from forming higher covers in otherwise suitable areas around the lake.

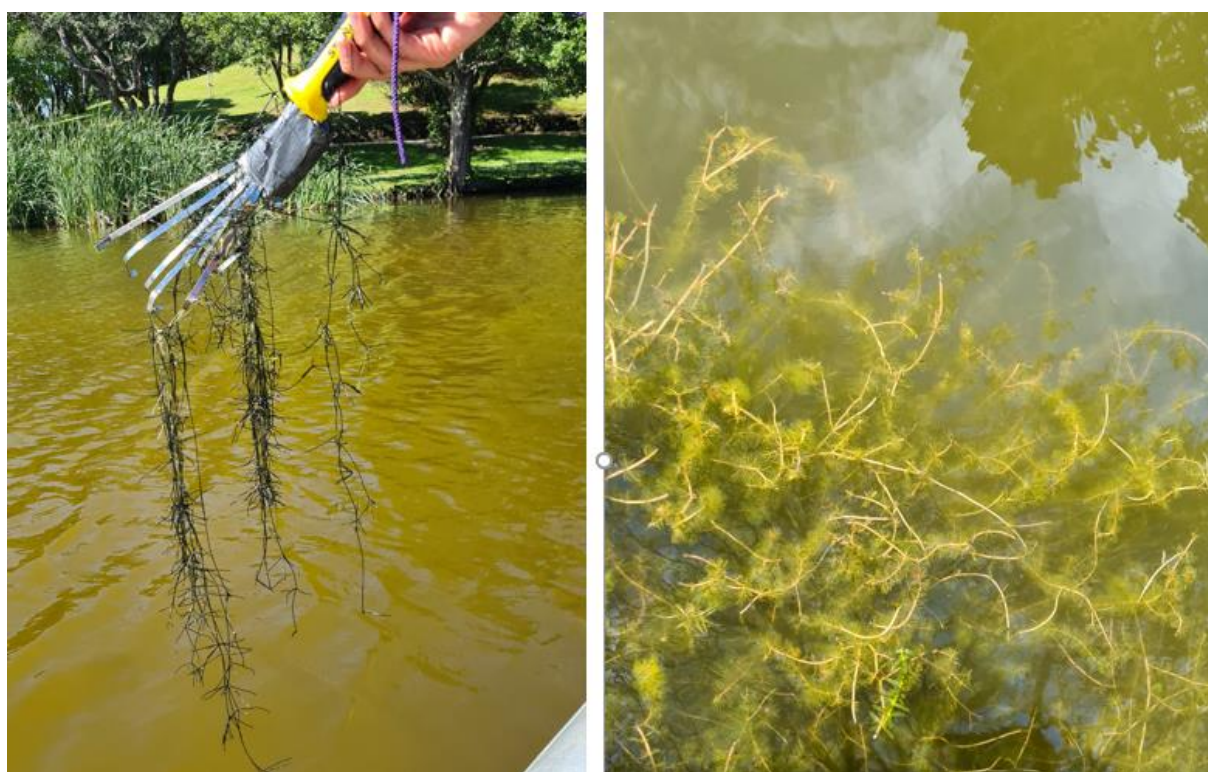
Native vegetation consisted of the pondweed *Potamogeton ochreatus*, milfoil *Myriophyllum triphyllum* and two charophyte species (*Chara australis* and *Nitella* sp. aff. *cristata*) (Figure 113). Native covers were variable between sites. Both charophyte species formed meadows (>75% cover) at one site each, extending down to a maximum depth of 5.4 m.

At the time of the 2020 survey, a thick yellow/brown phytoplankton bloom (Figure 113) prevented divers from being able to enter the water. No freshwater mussels were observed using the topside monitoring methods used to carry out this investigation. High numbers of waterfowl were present.

**Figure 113: Native charophytes on a grapnel (Left); surface reaching milfoils (Right) in Lake Virginia (2020).** Spot small fragment of Egeria centre bottom on Right. Note: colour of water due to algae bloom.

Lake Virginia remains at further risk of invasion from hornwort (*Ceratophyllum demersum*), with contaminated recreational gear likely representing the greatest threat.

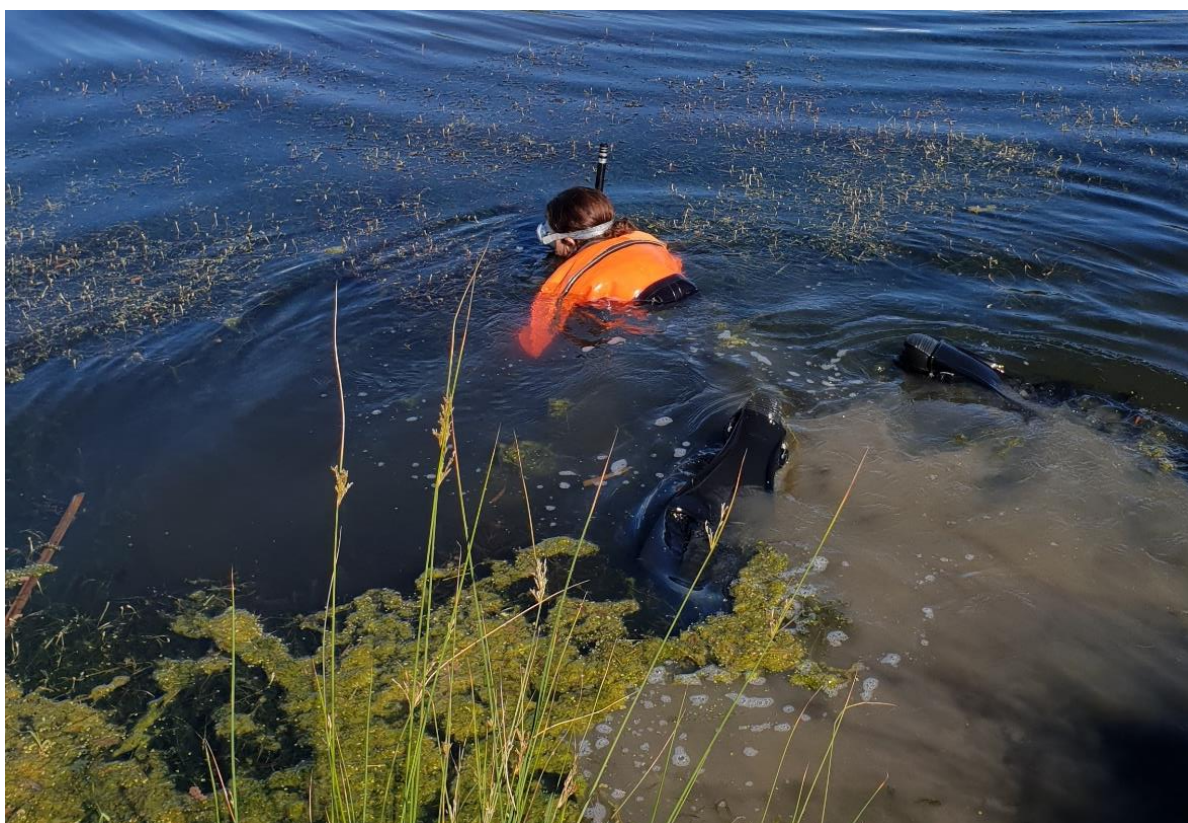
**Figure 115: Diver swimming across a profile in Voss Lagoon.** Note: filamentous green alga (bottom) and surface reaching plants (above).

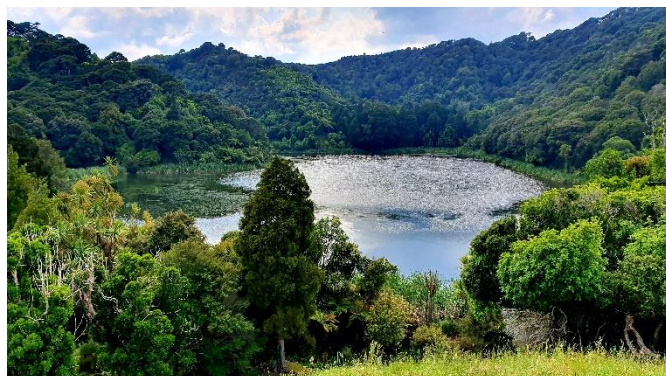
Lake condition:	Excellent
Lake ranking:	7 <sup>th</sup>
Lake maximum depth:	6.4 m
Max depth of vegetation:	4.2 m

Survey Date	Status	LakeSPI %	Native Condition %	Invasive Impact %
December 2019	Excellent	83% <div><div></div></div>	65% <div><div></div></div>	0%

Lake Waipakuranui is categorised as being in excellent condition, representative of those lakes in the Manawatū-Whanganui Region that maintain a well-developed native plant community in the absence of any invasive weed species (Table 3). This is reflected in a high LakeSPI Index of 83% and Native Condition Index of 65%.

While threats from invasive weed species appear minimal on account of restricted public access into Lake Waipakuranui, it is advisable that the land owners be notified to exercise discretion in allowing access to the lake for users of equipment that may be contaminated with invasive species (e.g., boats used for duck shooting, eel fishing nets).

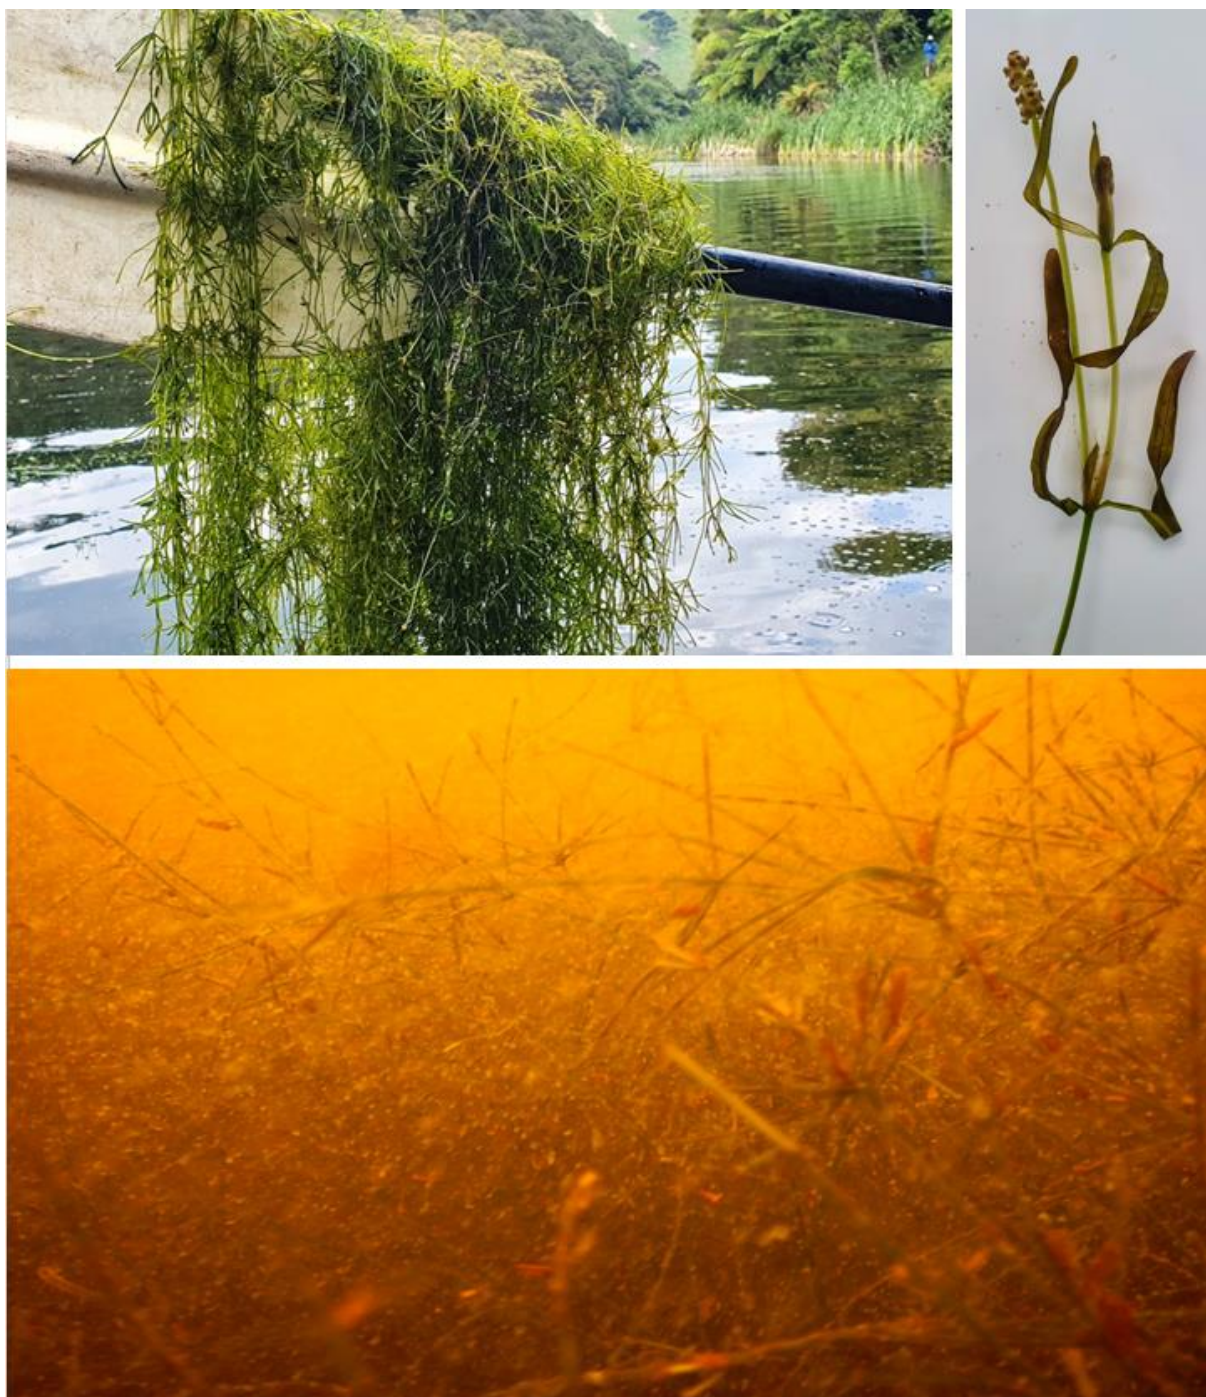
A dense stand of emergent species (*Typha orientalis*) surrounded the lake growing down to c. 1 m in depth. Beyond this, two native charophytes (*Chara australis* and *Nitella* sp. aff. *cristata*) formed meadows (>75% cover) at all four LakeSPI sites (Figure 117). Charophytes were tall, in places up to 1.9 m in height, and extended down to a maximum depth of 3.4 m. A native pondweed, *Potamogeton ochreatus* (Figure 117Figure 116), was also present at all sites growing through the charophytes and extended down to a maximum depth of 4.2 m. *Potamogeton ochreatus* grew up to 3.8 m tall and was surface reaching in shallower areas around the lake.

**Figure 117: Submerged plants in Waipakuranui.** Native charophyte *Chara australis* (top left); native Pondweed *Potamogeton ochreatus* (top right); and charophytes as seen underwater (bottom) .

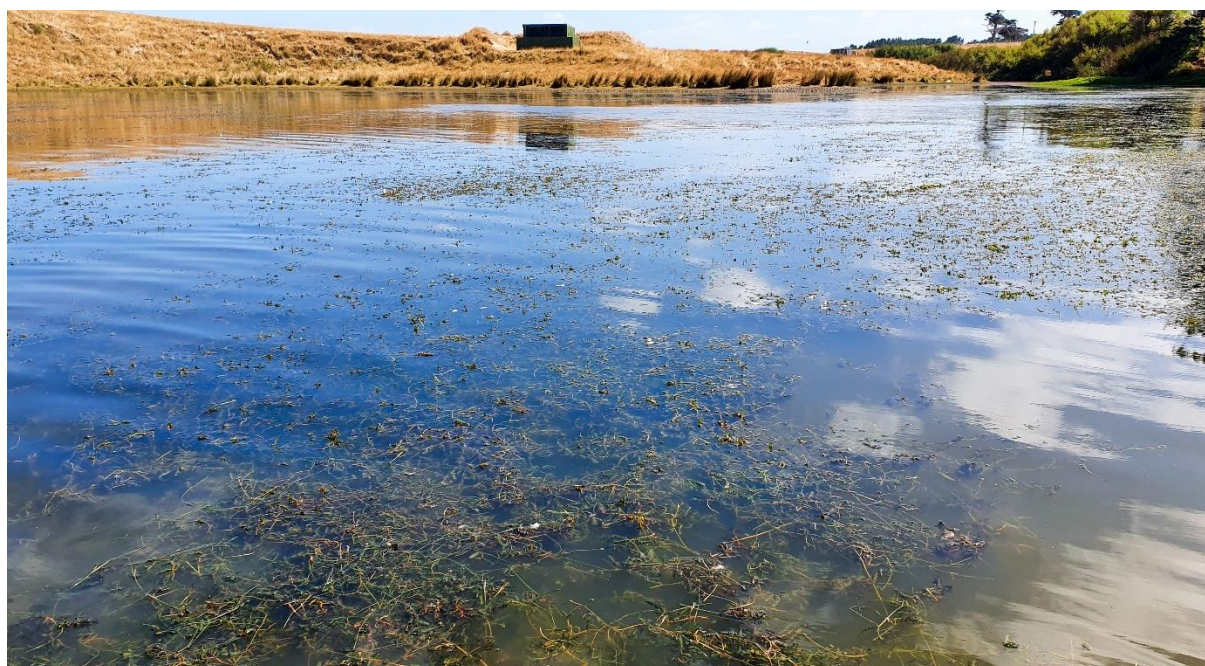
During the recent (2020) survey, the introduced pondweed *Potamogeton crispus*, dominated the submerged vegetation in Lake Waipu and was surface reaching over at least a third of the lake surface, at the northern end (Figure 119). At LakeSPI sites, *P. crispus* formed moderate to high covers from the shallows extending down to a maximum depth of c. 3 m.

**Figure 119:** Surface reaching *Potamogeton crispus* in Lake Waipu.

While threats from additional weed species appear minimal on account of restricted public access into Lake Waipu, it is advisable that the land owners be notified to exercise discretion in allowing access to the lake for users of equipment that may be contaminated with invasive species (e.g., boats used for duck shooting, eel fishing nets).

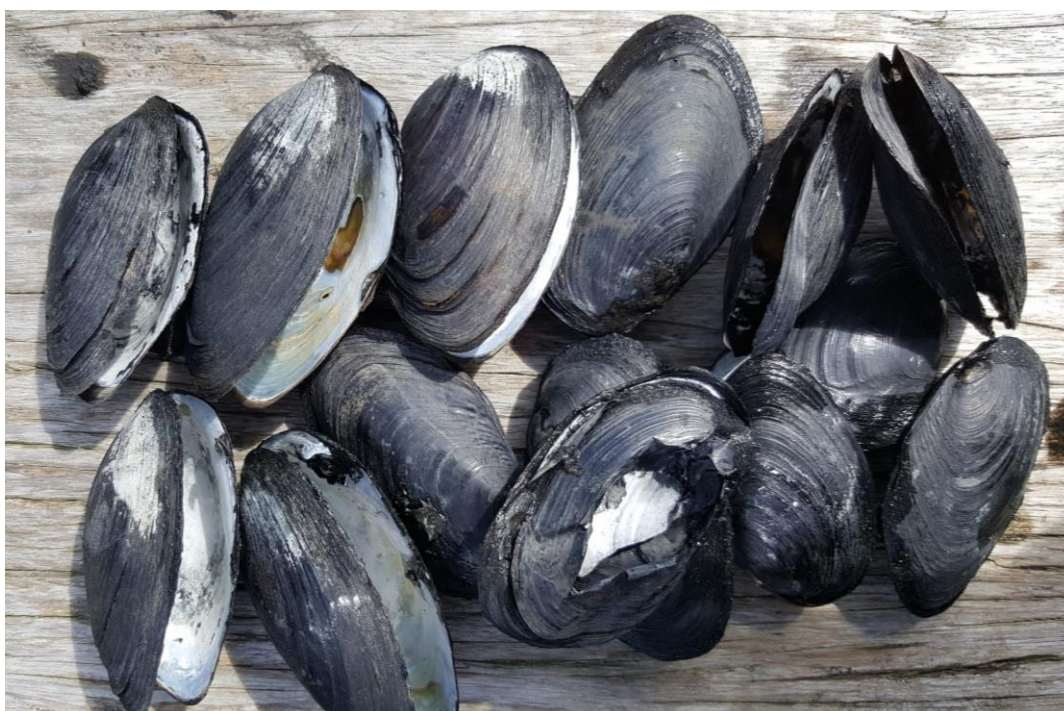
**Figure 122:** Large numbers of freshwater mussels (either dead or dying) were found beyond egeria weed beds in Lake William.

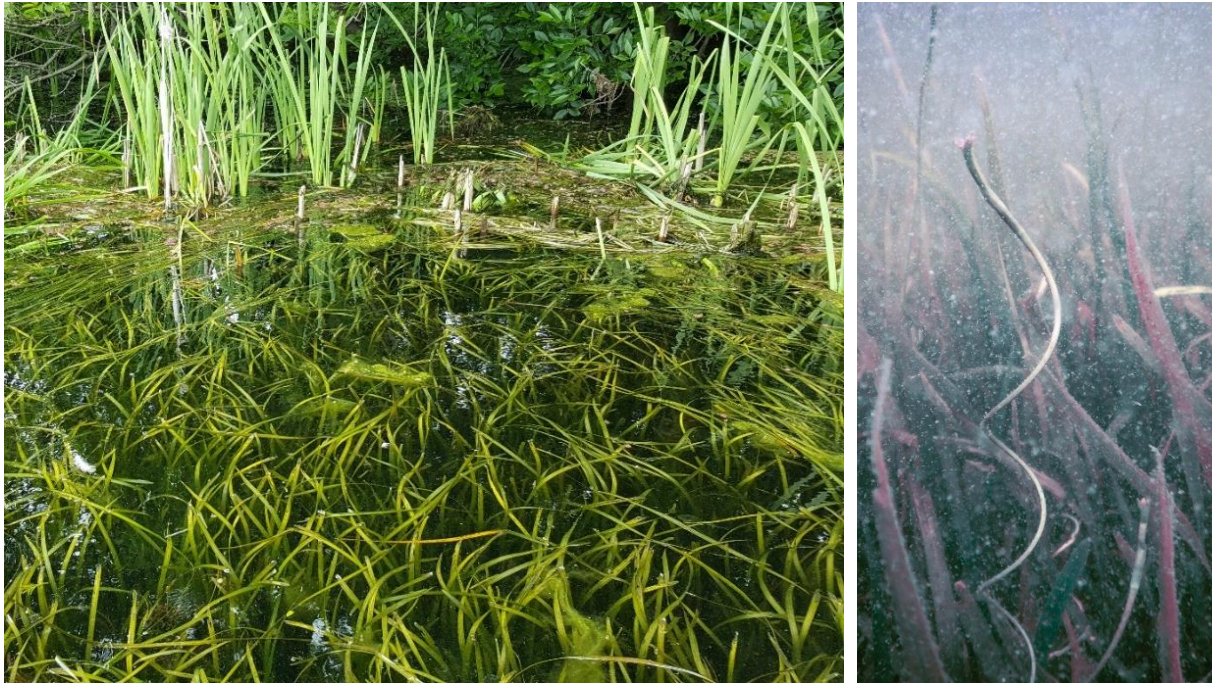
**Figure 124:** Invasive species *Vallisneria australis* (eel grass) formed a dense band around the lake margin of Lake Wiritoa. Flower on right.

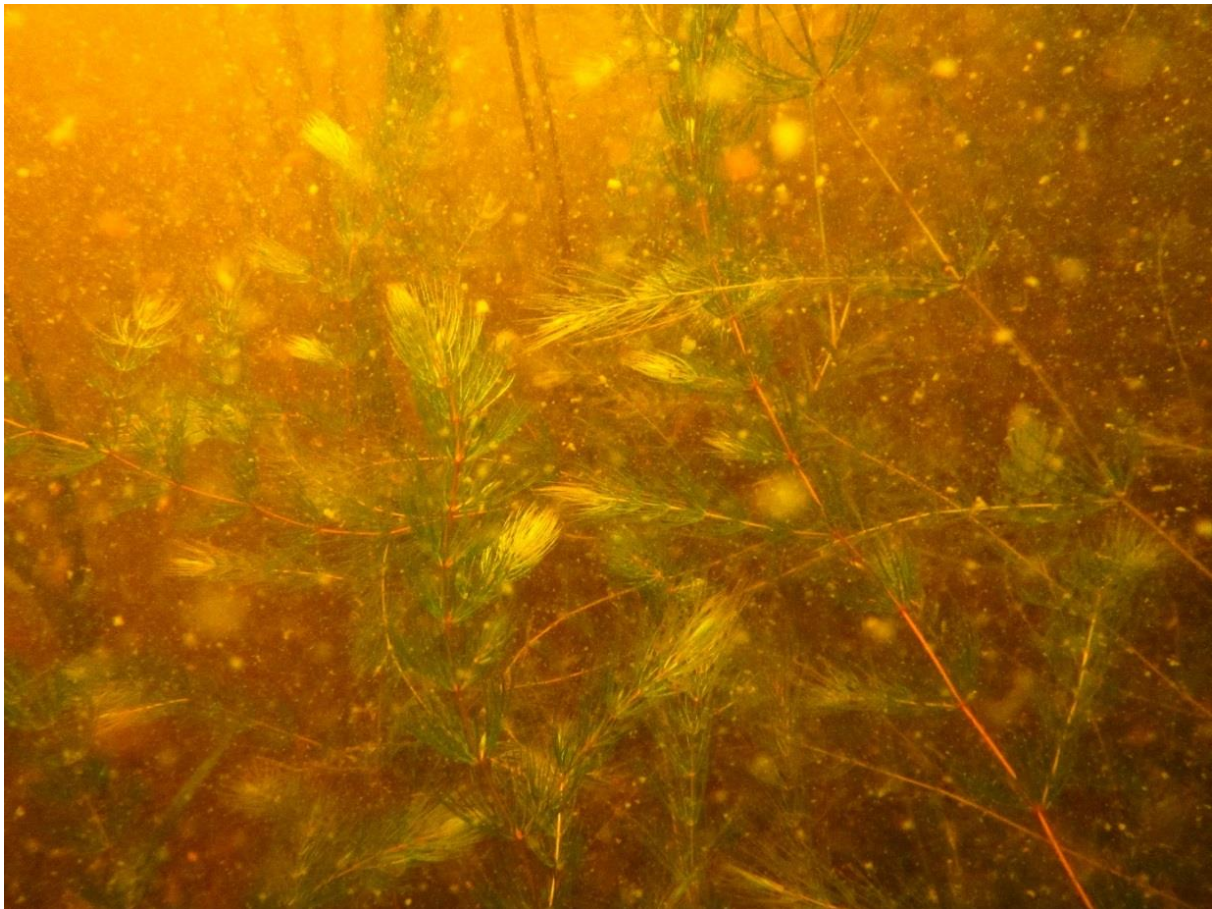
Eel grass (*Vallisneria australis*) formed a dense surface-reaching fringe of weed around most of the lake margin (Figure 124) to a maximum depth of 3.6 m. Beyond this, hornwort (*Ceratophyllum demersum*) (Figure 125) formed a second band of weed into deeper water, growing up to 4.5 m tall and extending down to a maximum depth of 6.8 m. Other invasive species present included the introduced pondweed *Potamogeton crispus* and occasional plants of *Egeria densa*.

**Figure 125:** Hornwort formed a tall weed bed in Lake Wiritoa up to 5.5 m high.
